**In the matter of 85-89 SUTTON STREET, NORTH MELBOURNE
AMENDMENT C207 TO THE MELBOURNE PLANNING SCHEME: ARDEN
-MACAULAY HERITAGE AMENDMENT**

Expert Witness Statement of Mr Kevin Desmond Campbell

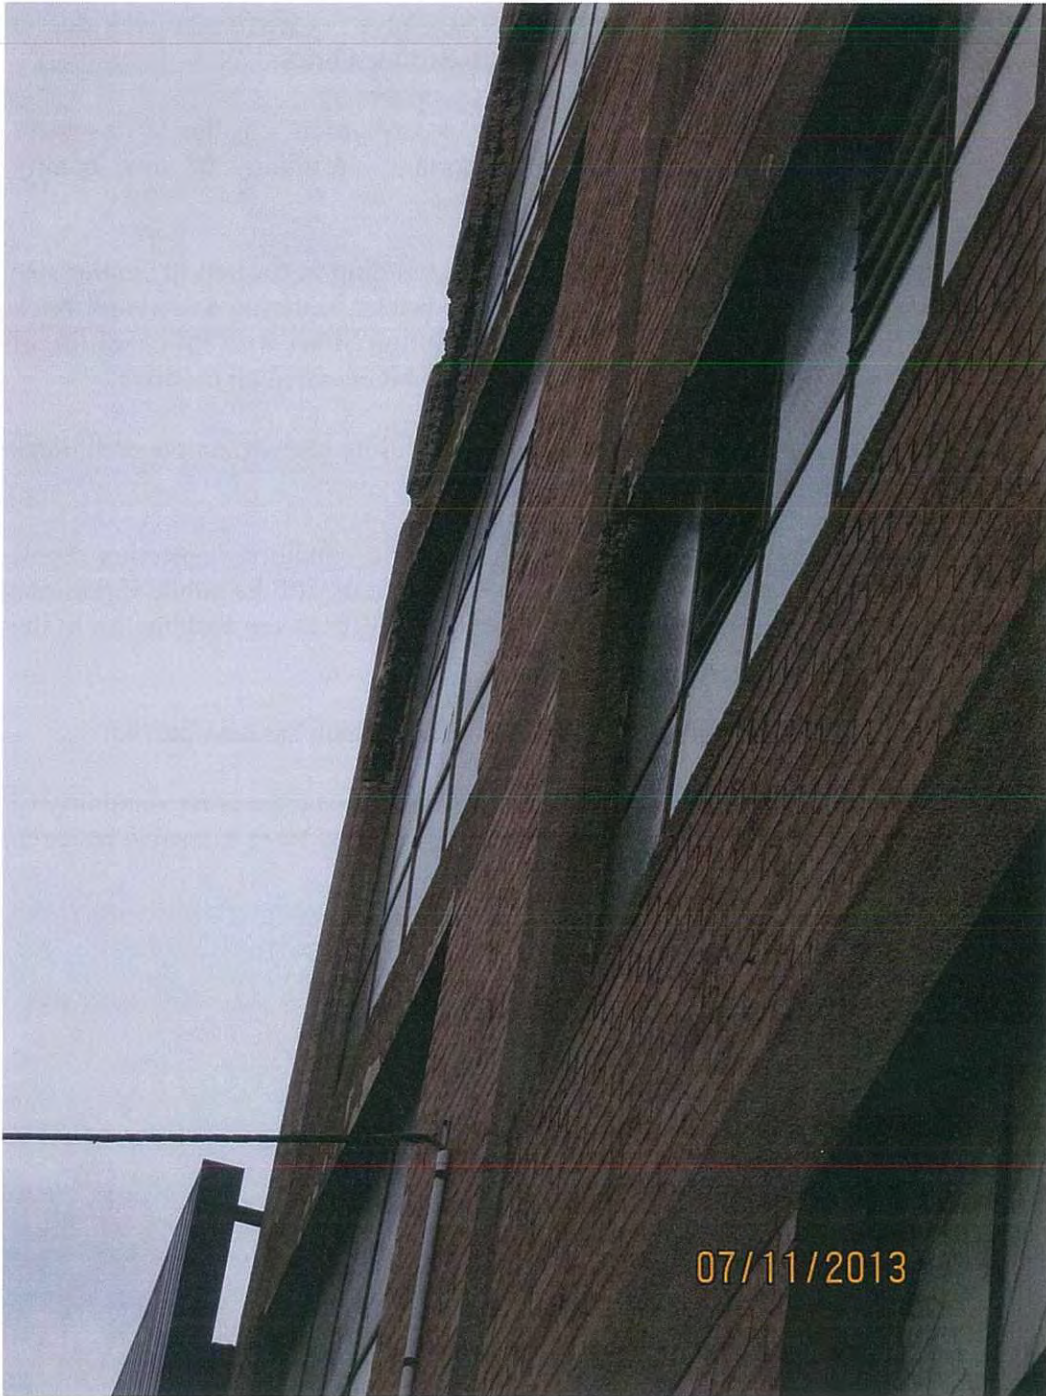
Steel window framing bowed

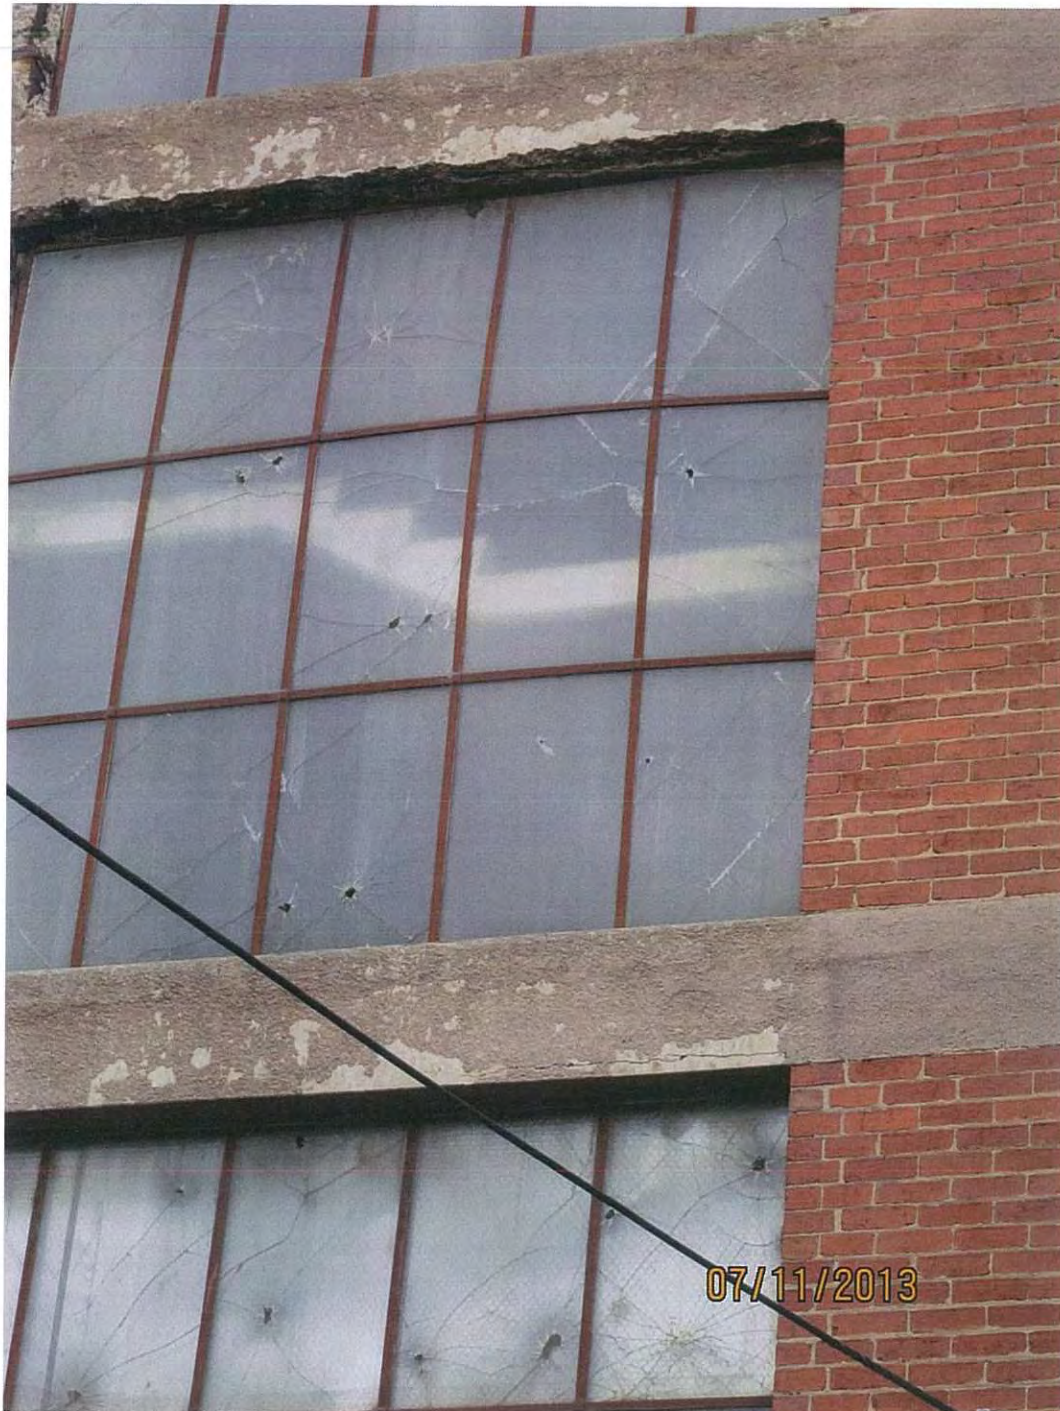
Steel window framing bowed. Glazing breaking into shards. Will fall on footpath.

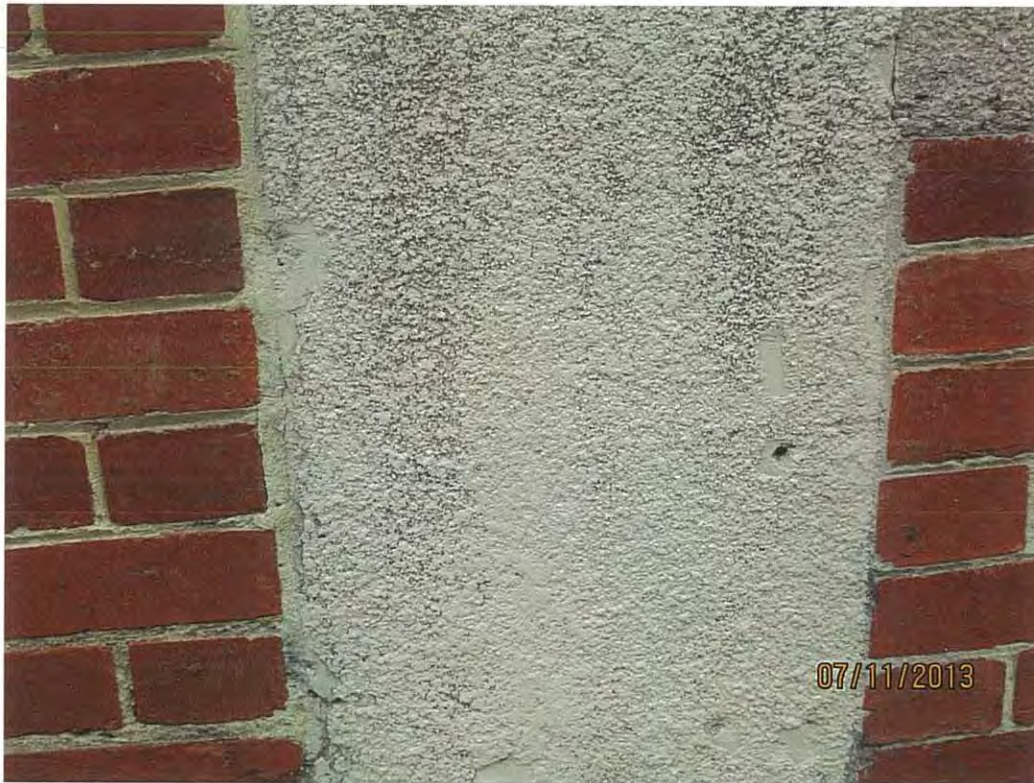
Solid mortar joints – no allowance for expansion

There are no expansion joints in the brickwork. Expansion joints require full depth chasing out to 15mm width and sealed with sikaflex.

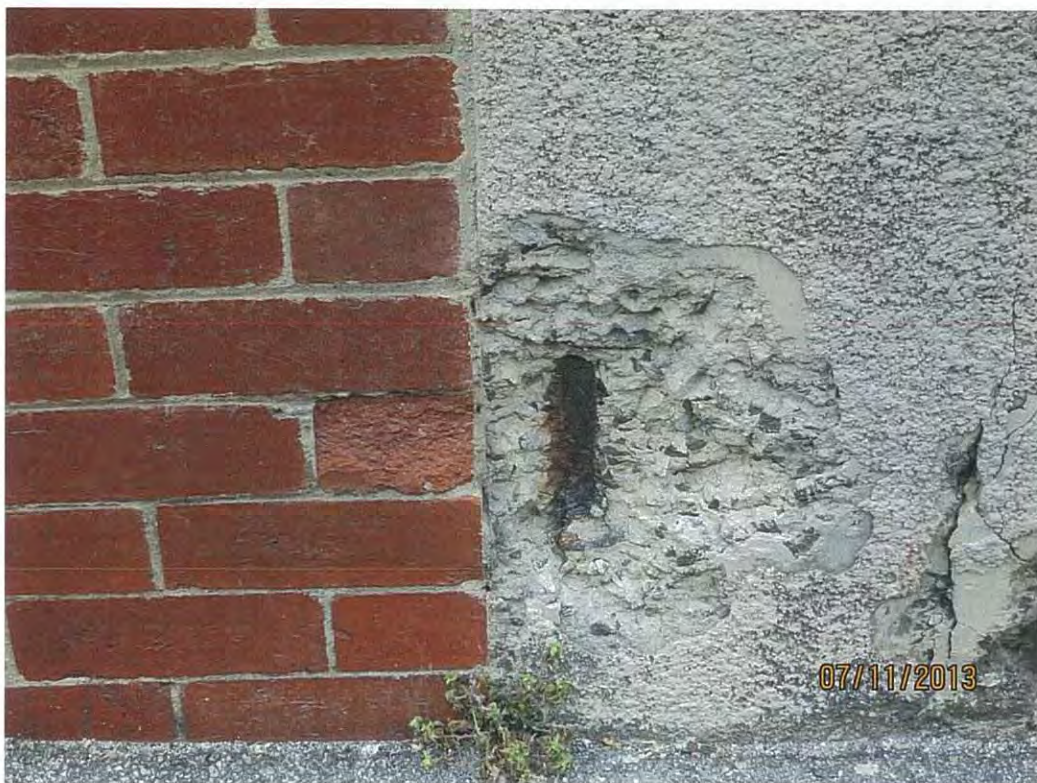
Expansive brickwork spalling. Spalling concrete due to steel corrosion.

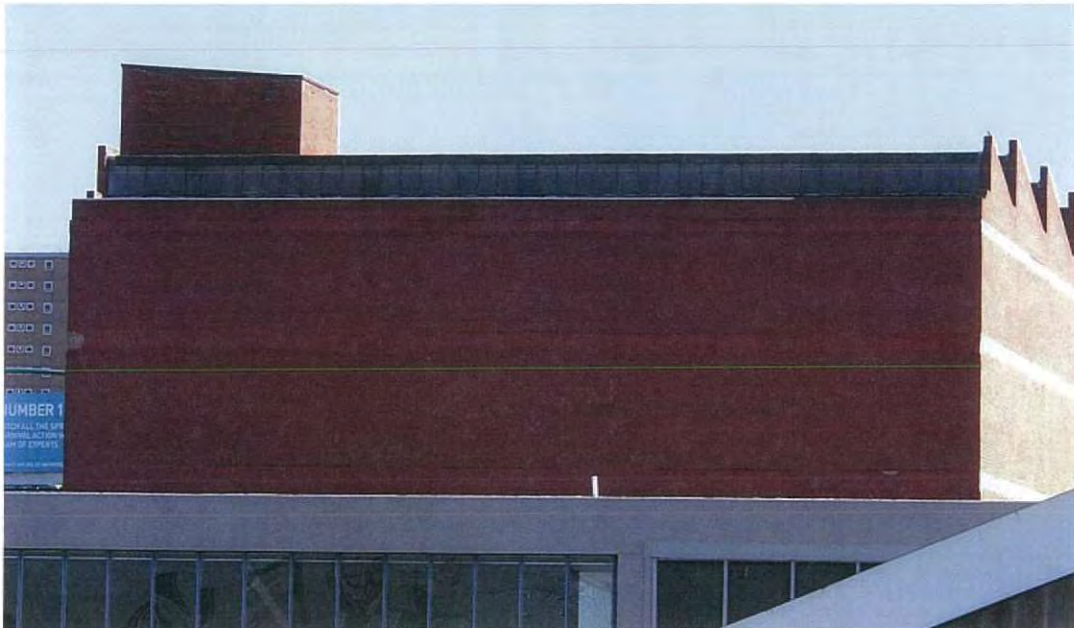
Southern elevation spray painted to match brick work and conceal distress.
Part eastern elevation – note: no expansion joints in southern elevation or eastern elevation. No capping on saw tooth brickwork. Capping on plant room brickwork

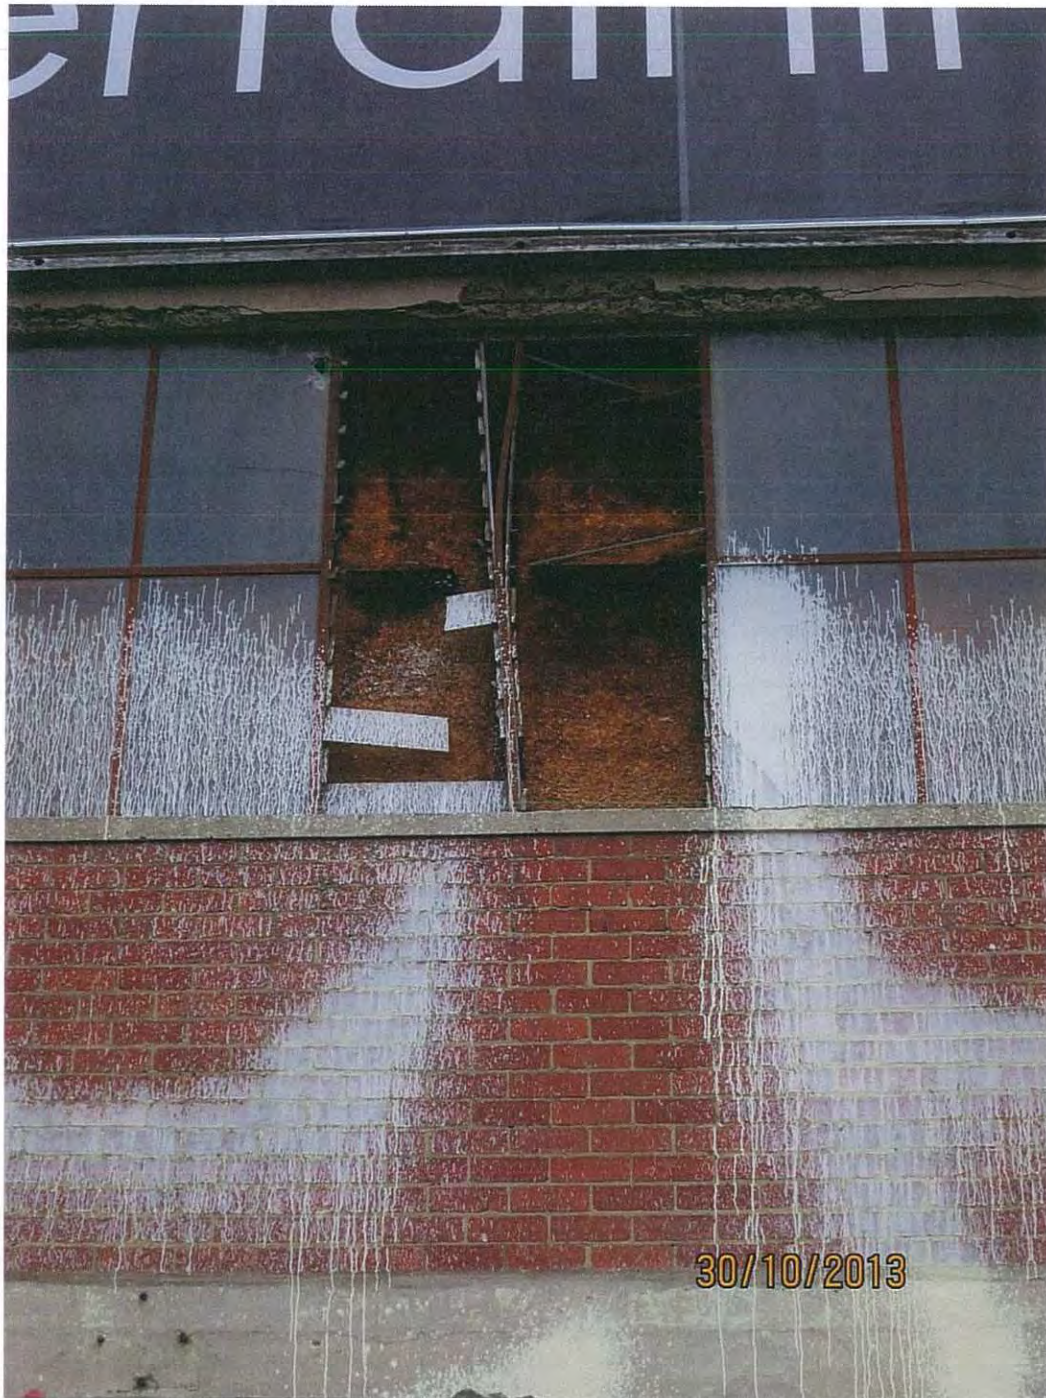
Failed lintel and failed metal window frames

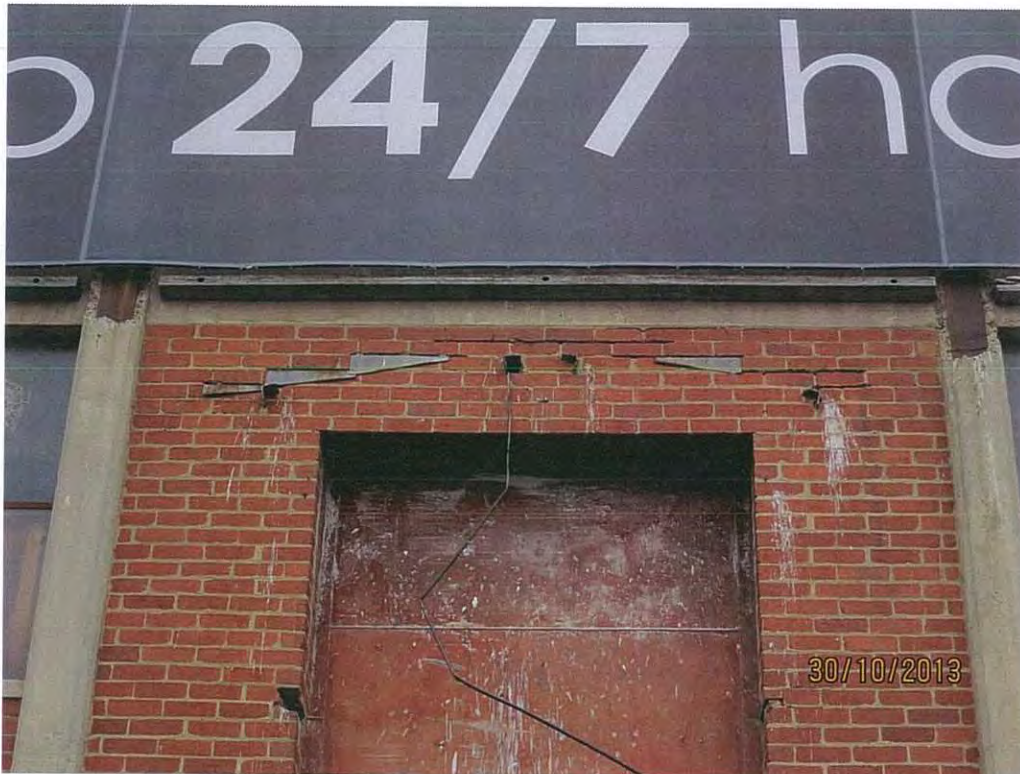
Spalling of concrete on steel columns and failed brickwork.

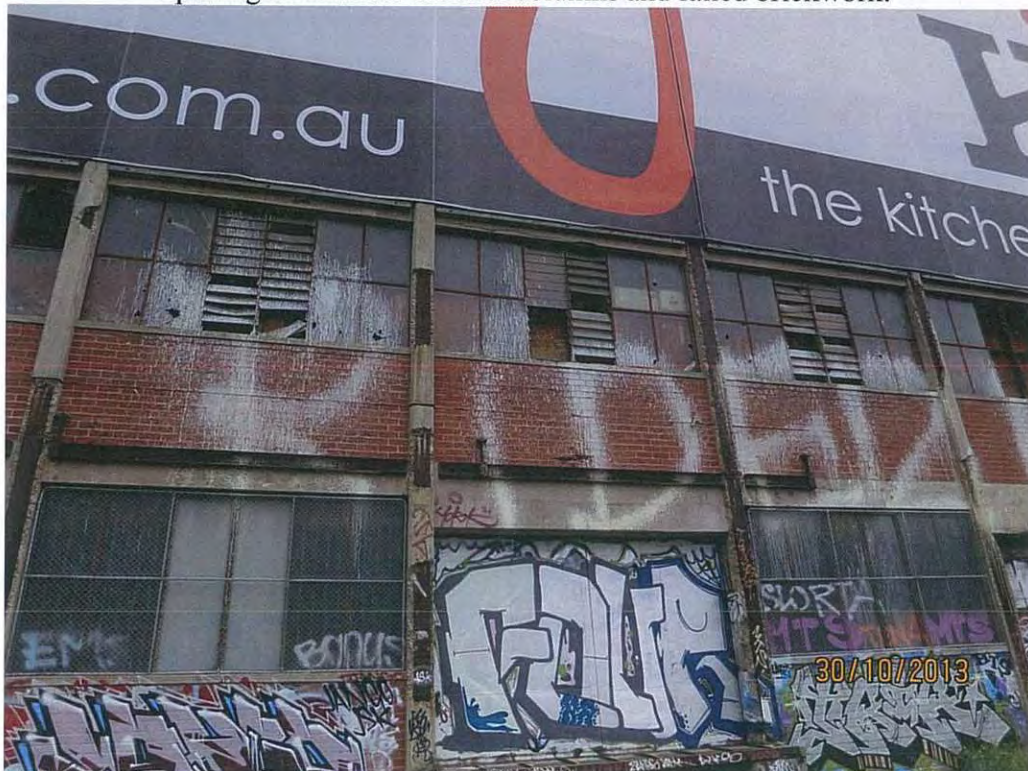
Spalled concrete on columns. Failed brickwork. Failed metal window frames and glazing.

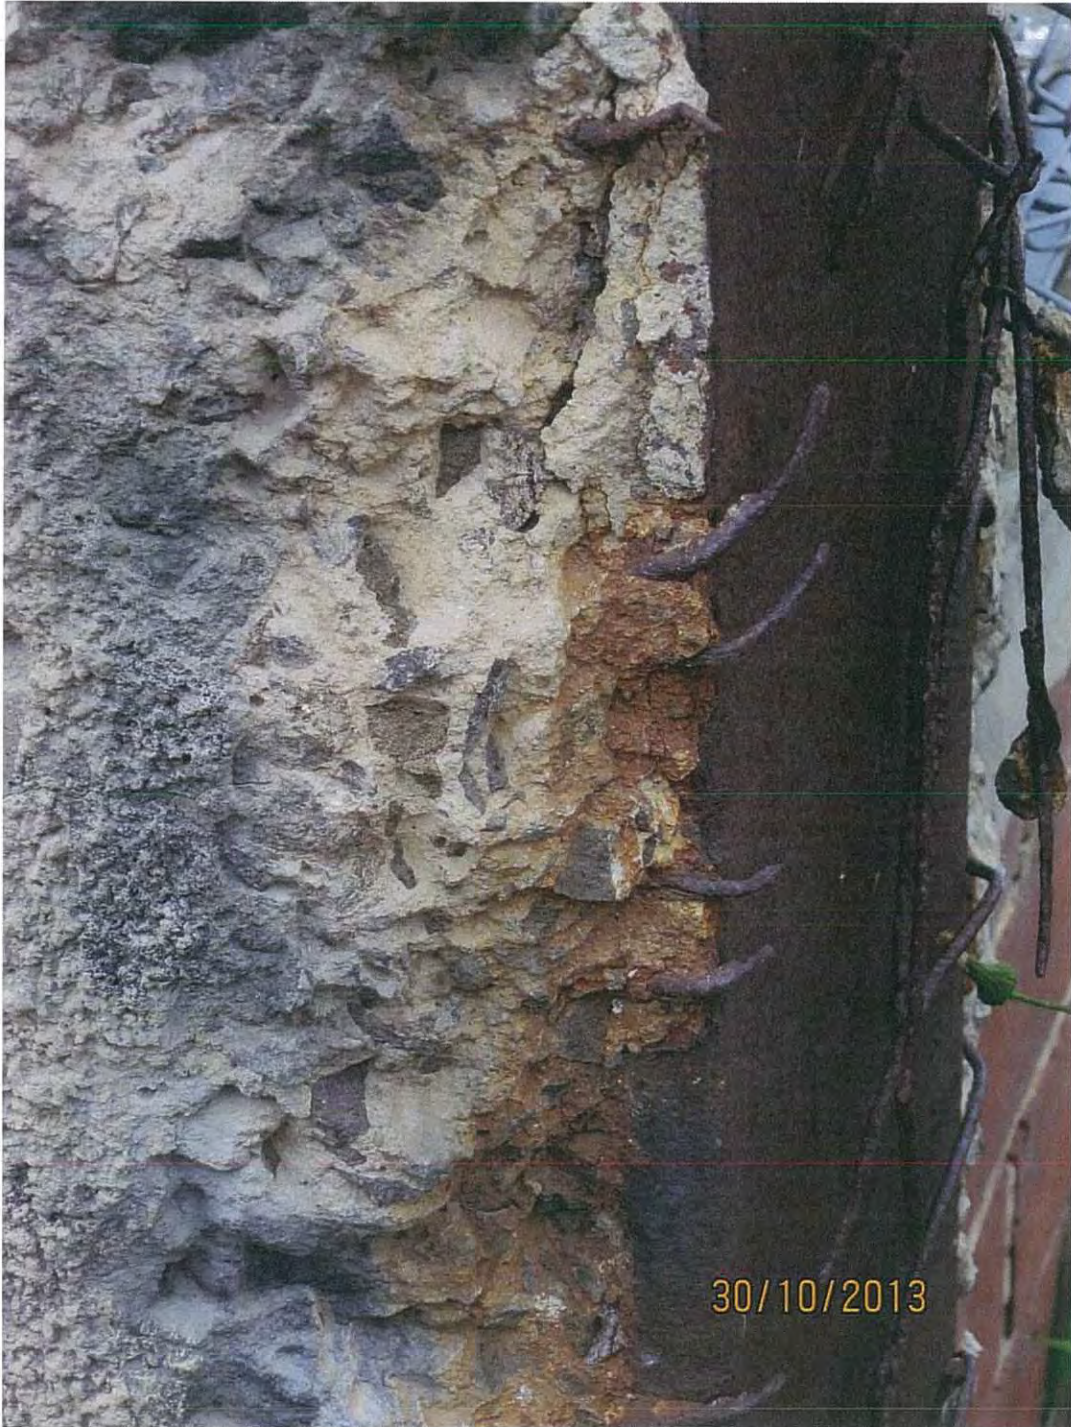
Severely corroded steel column. Failed reinforcement and spalled concrete.
Inadequate cover.

The structural steel column sections are extensively corroded and severely pitted. The steel sections require grit blasting and coating with a zinc epoxy for durability. The concrete fireproofing has failed requiring complete replacement with a 32MPa concrete, galvanised fabric and increased cover to comply with *AS3600 Concrete Structure Code*. Drip grooves should be incorporated in the soffits of the lintel beams.

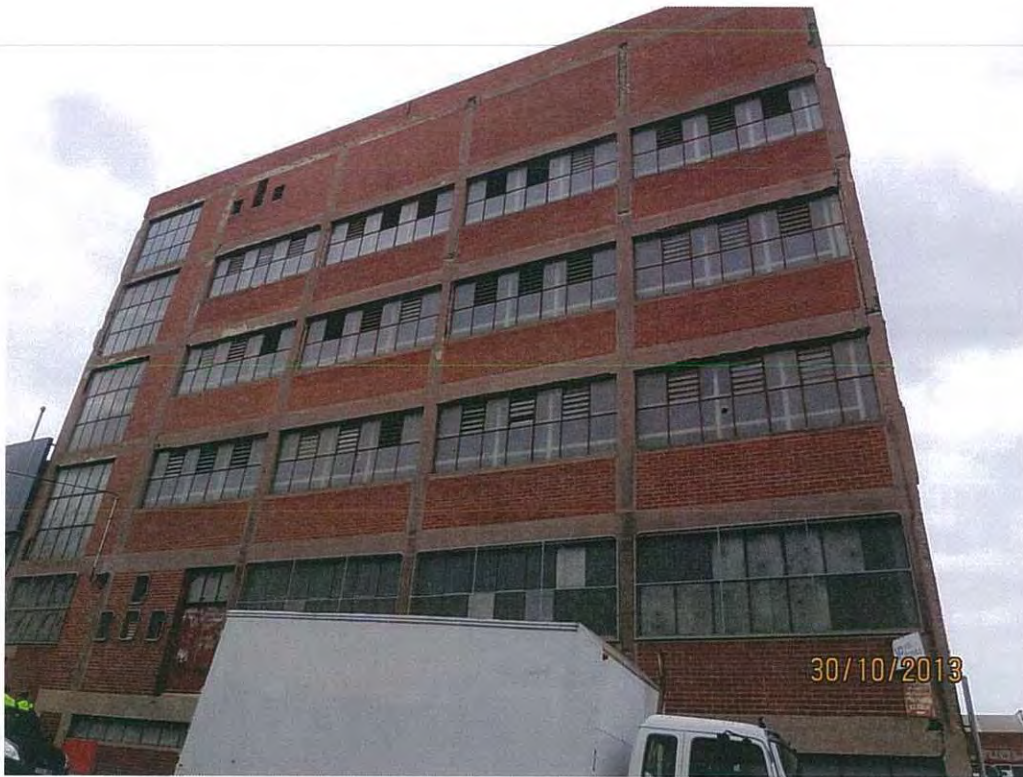
Northern elevation spalled concrete from columns and beams. Hoarding or gantry required.

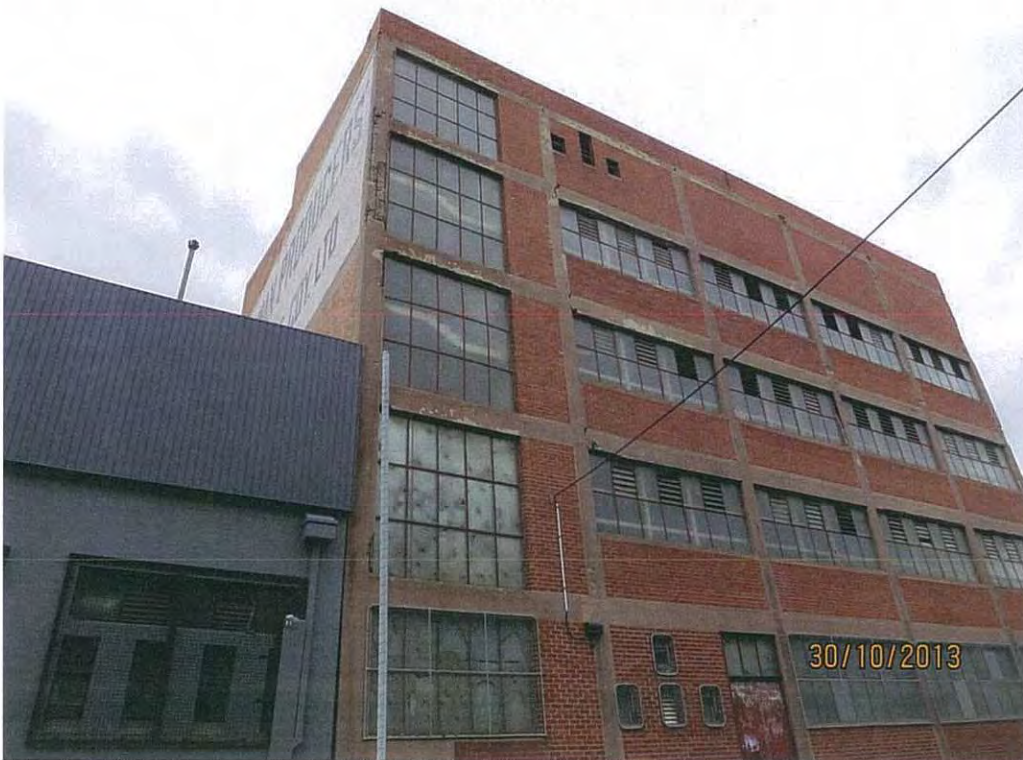
Northern elevation spalled concrete from column. Hoarding or gantry required.

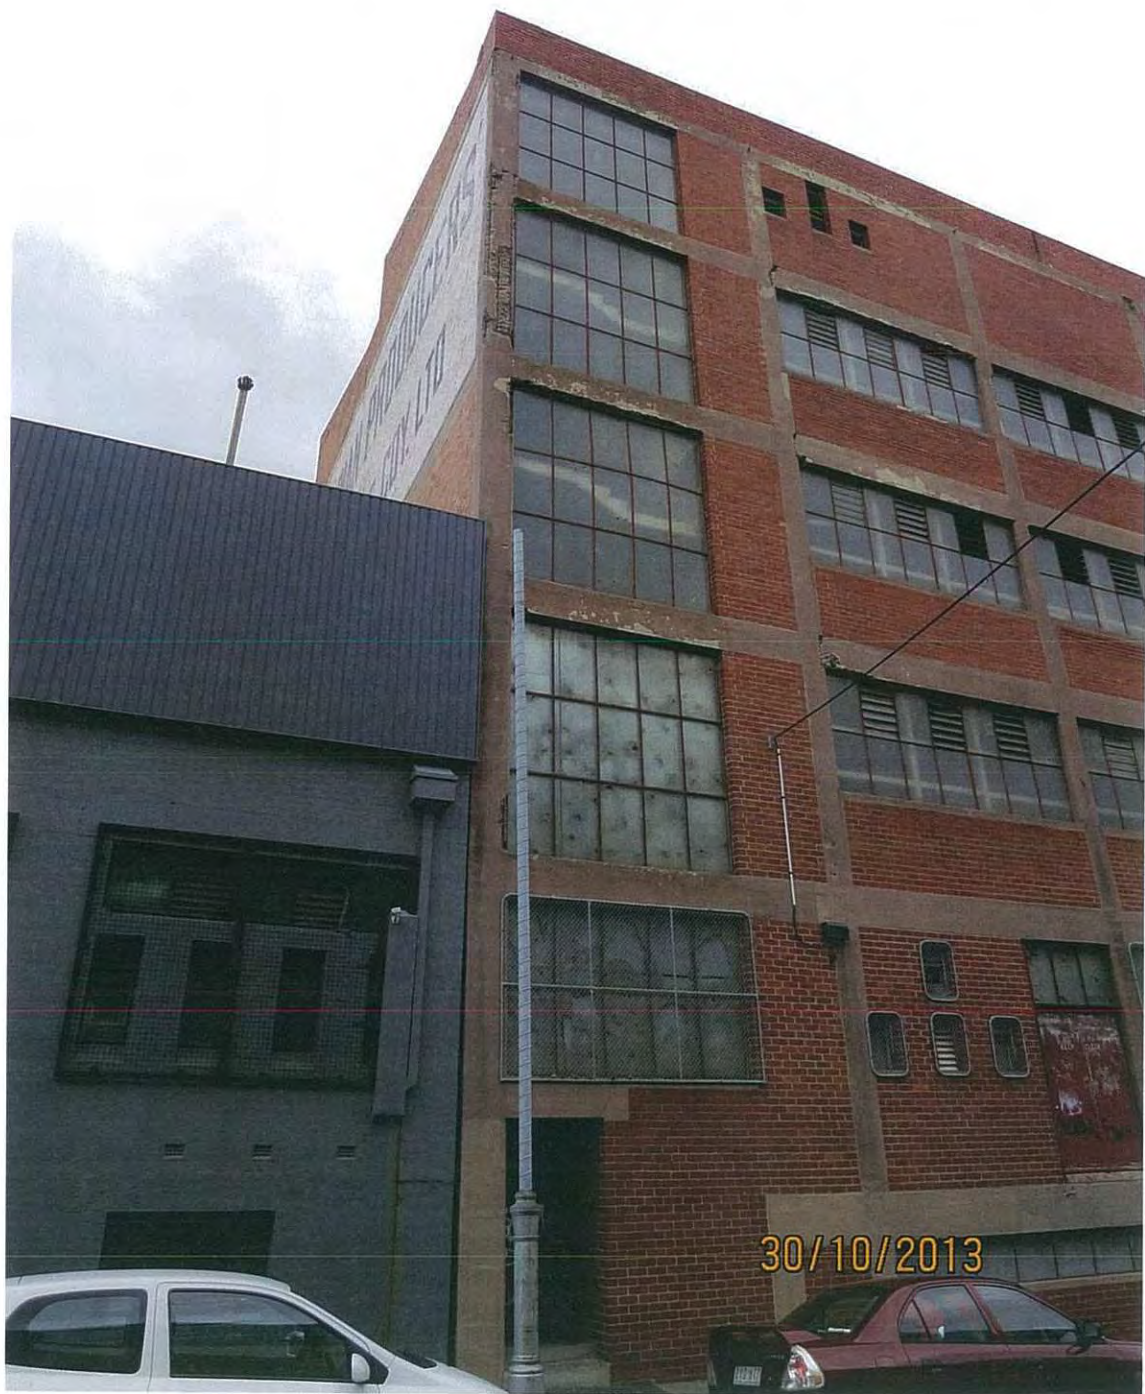
Spalling concrete from columns and beams. Gantry or hoarding required to protect pedestrians who use the footpath.

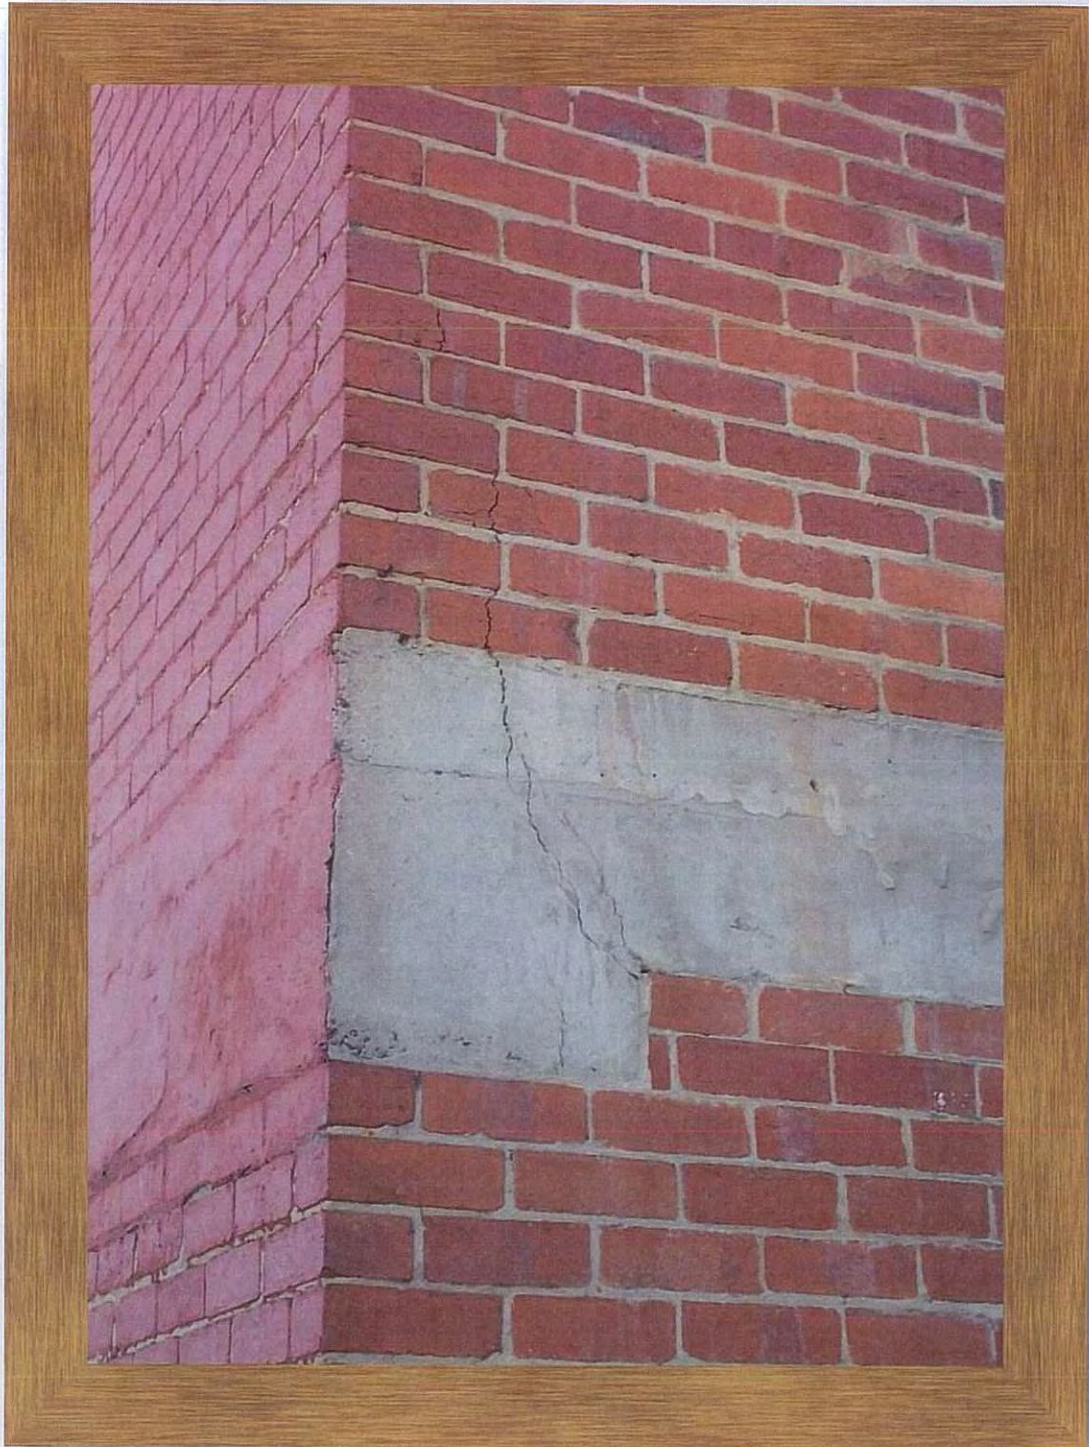
Eastern elevation – no expansion joints – brick expansion causing cracking of brickwork and perimeter beam

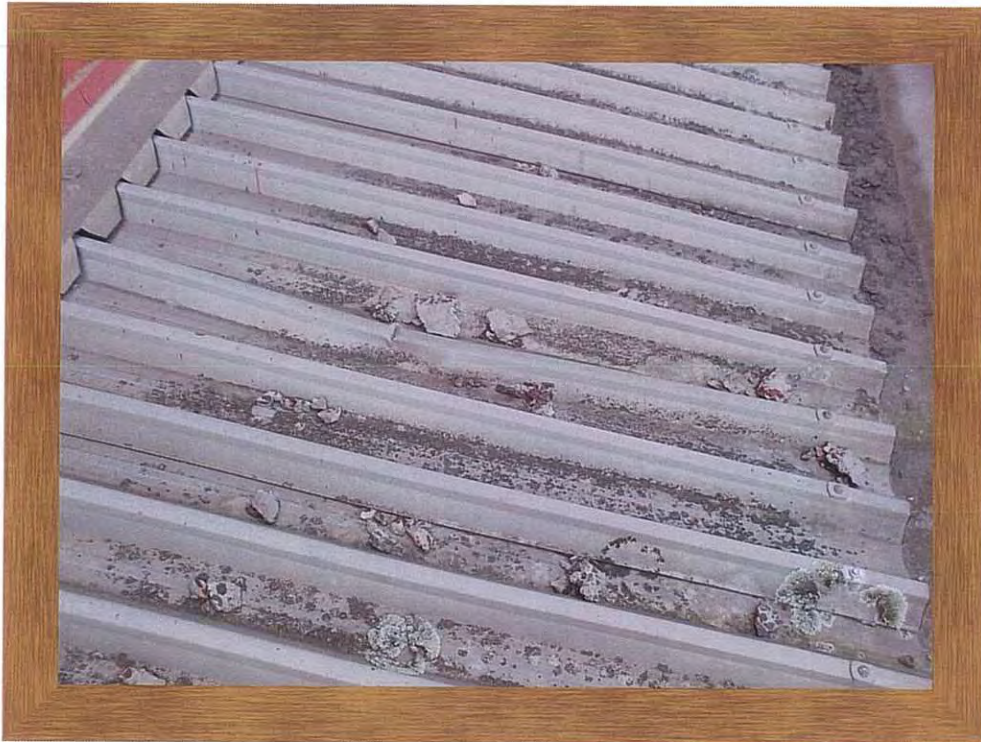
Spalls from Southern façade onto adjacent building

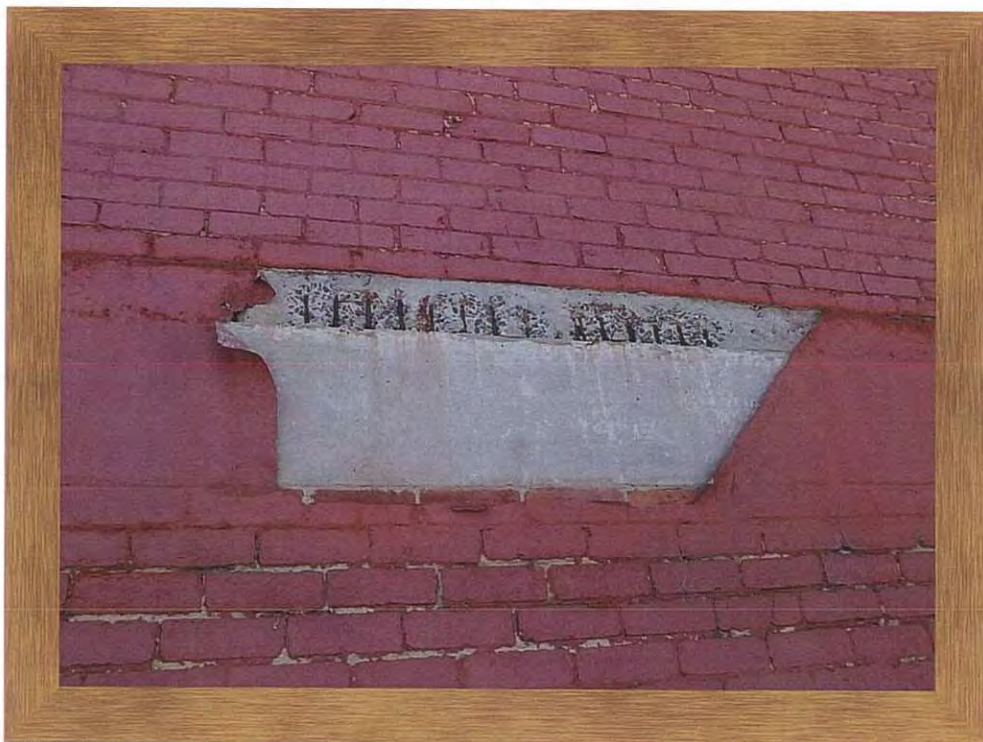
Spalling of Southern façade

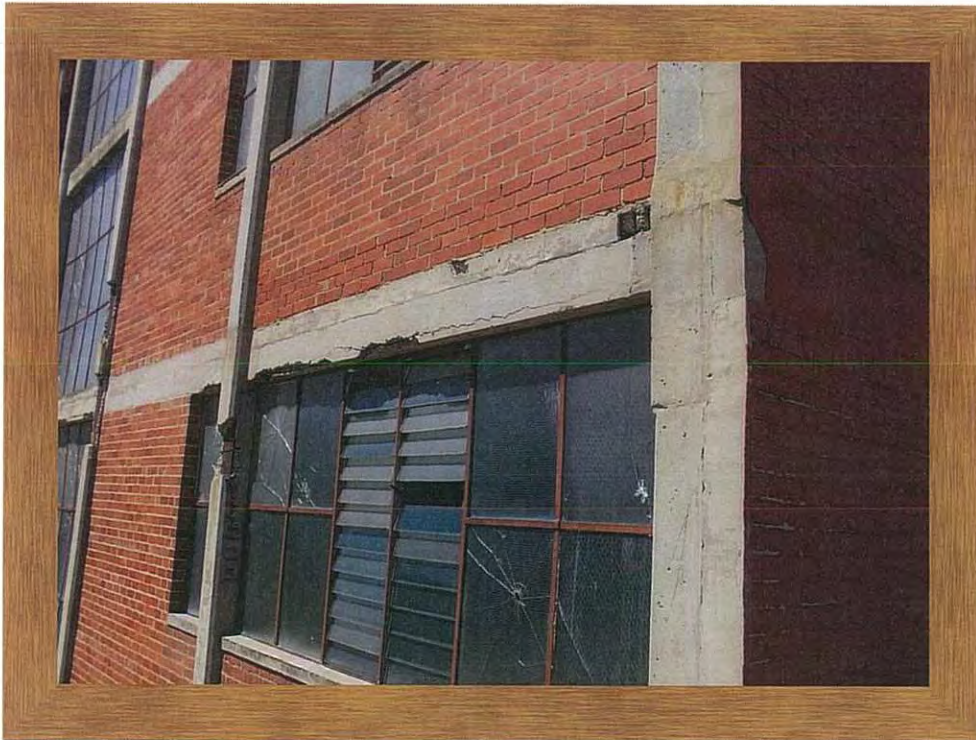
Western façade – corrosion of steel window frame and cracked window panes.
Spalling concrete lintel

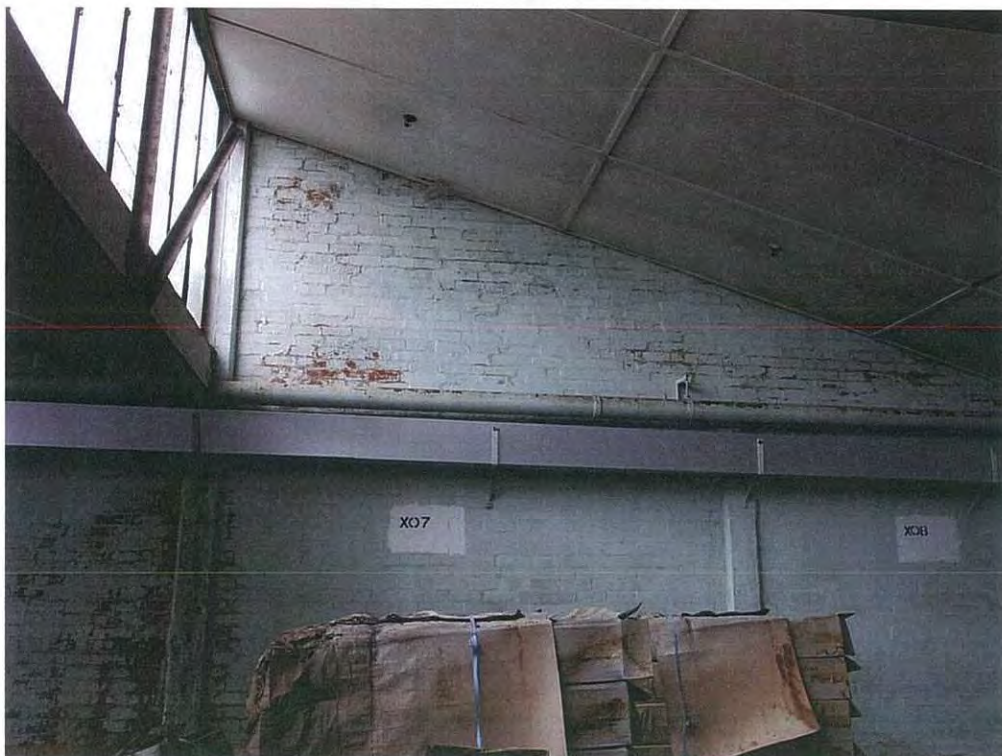
Expansive bricks in sawtooth brickwork require complete replacement

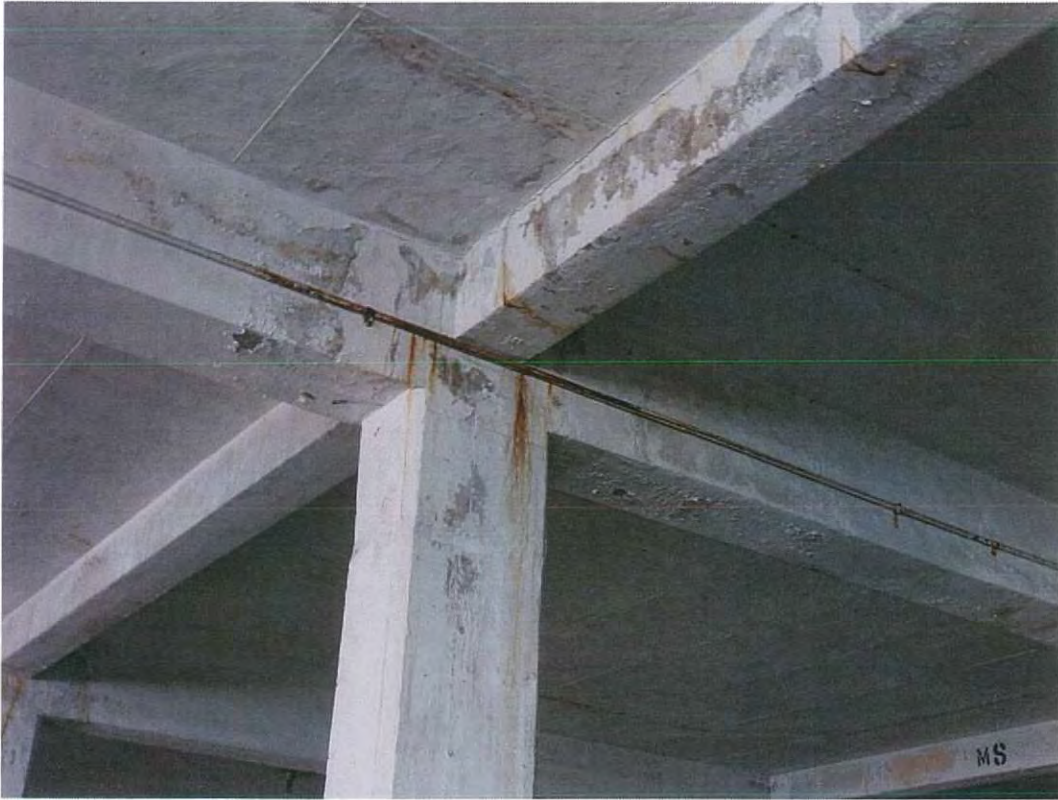
The internal concrete elements, floor, columns and beams are generally in good condition but are only 20-25MPa compressive strength and not suitable for exposure to the elements. The top floor columns are cracked due to expansion of brick sawtooth parapet elements and require extensive repair. The brick sawtooth parapet elements require removal and reconstruction with more stable brickwork. There is some corrosion of internal columns and beams due to ingress of water.

Internal concrete framework showing corrosion of reinforcement due to low strength concrete and moisture ingress into building

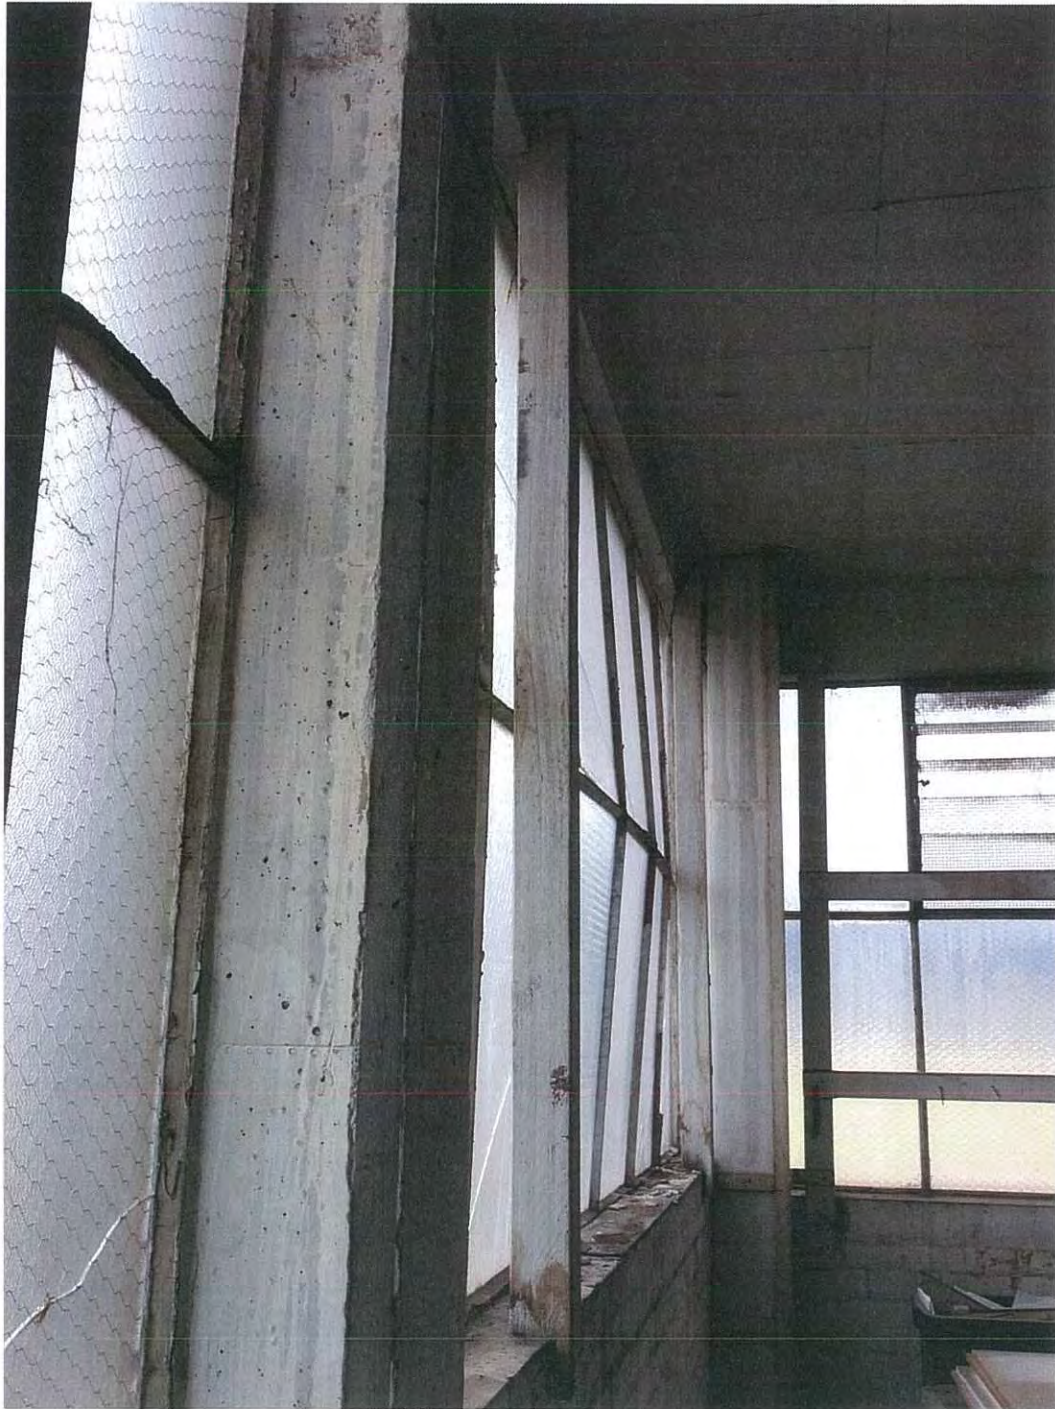
Bowing window frame causing glazing to break into shards

All the steel window frames and glazing require replacement. Potential falling glass shards are a hazard.

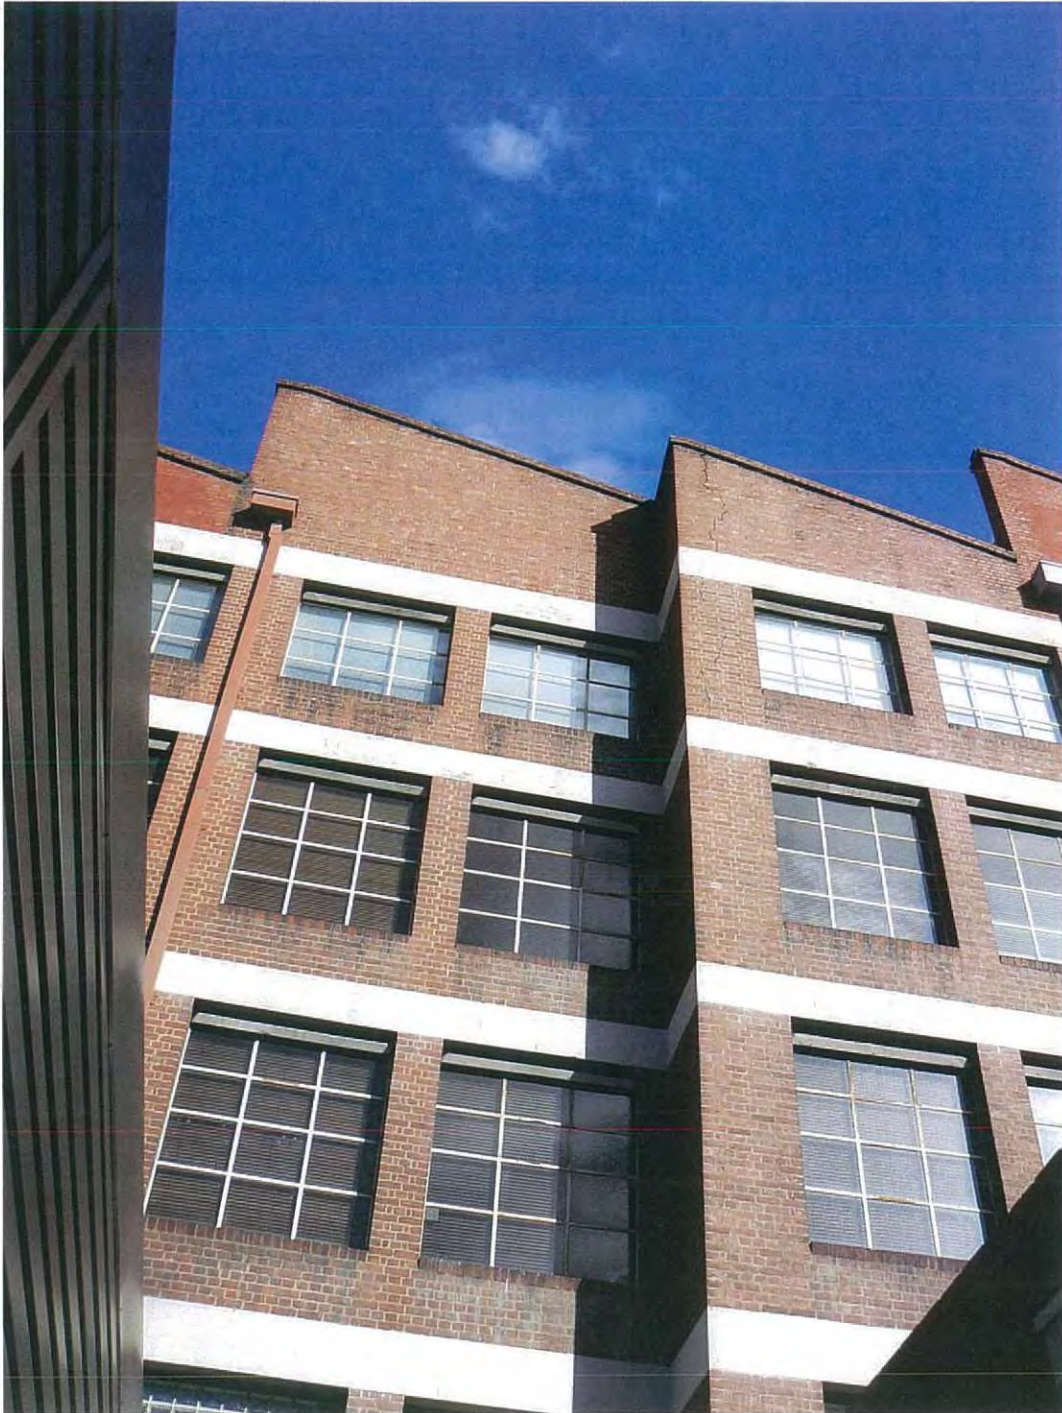
Saw tooth roof of clay brick on a building in Carlton. Repaired under supervision by Kevin Campbell Consultants in 2006.

Note: cappings on parapet and flashings on the soffits of lintel to protect steel window frames.
