# QUEEN VICTORIA MARKET

ELIZABETH STREET, MELBOURNE  
CONSERVATION MANAGEMENT PLAN

**QUEEN VICTORIA MARKET PTY LTD**

April 2003

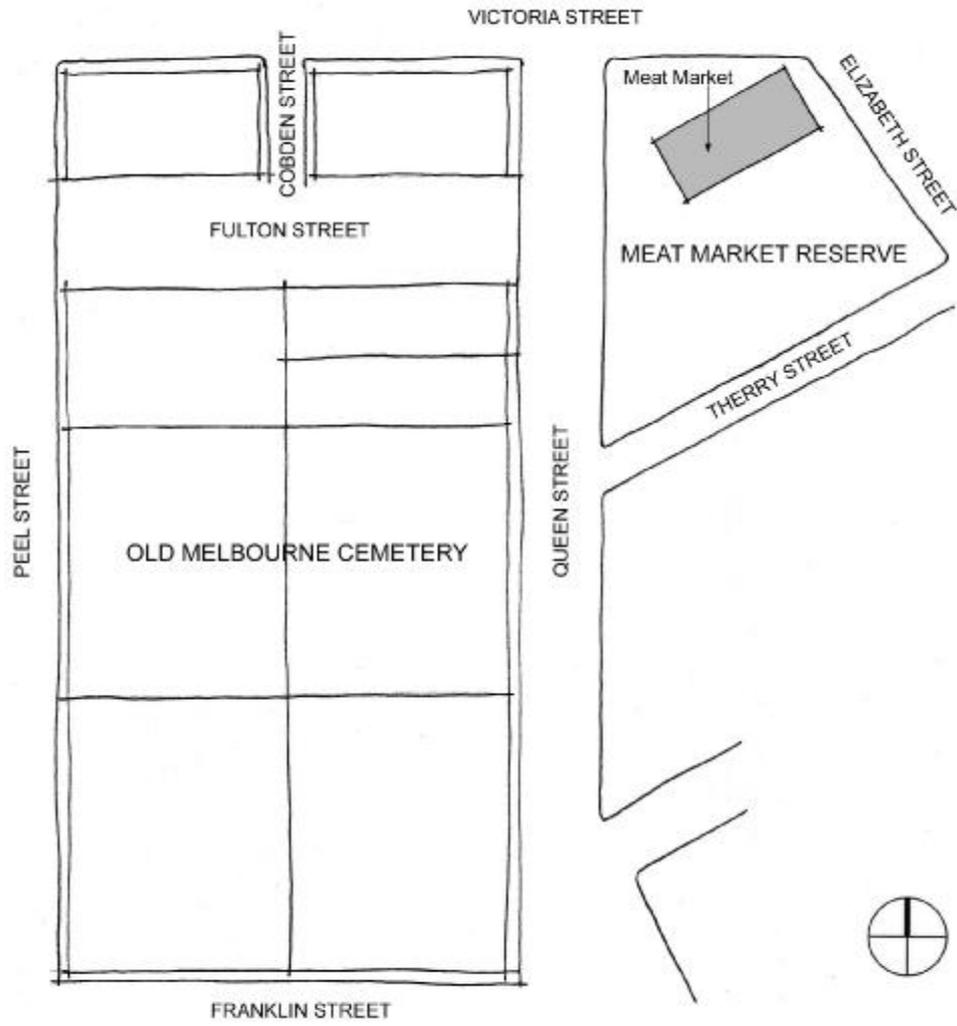
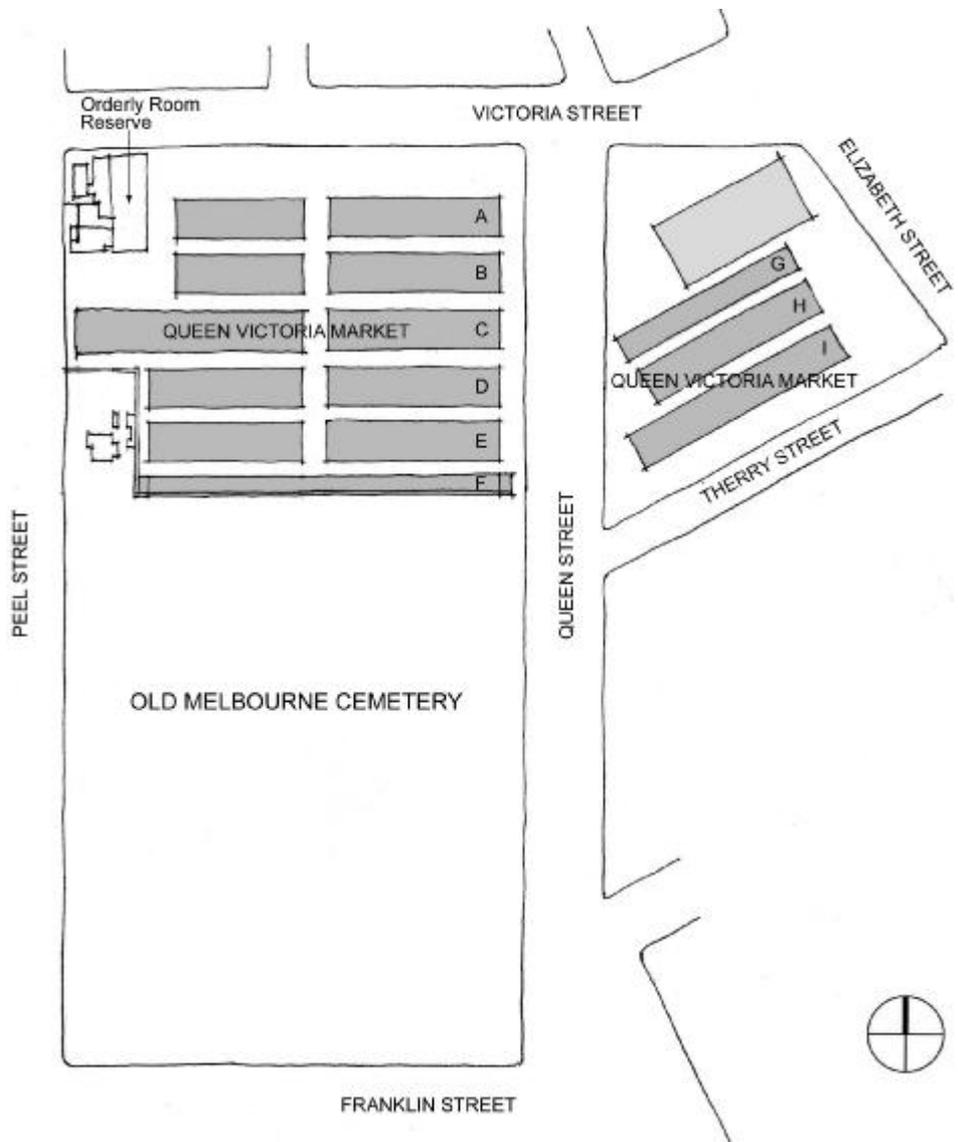
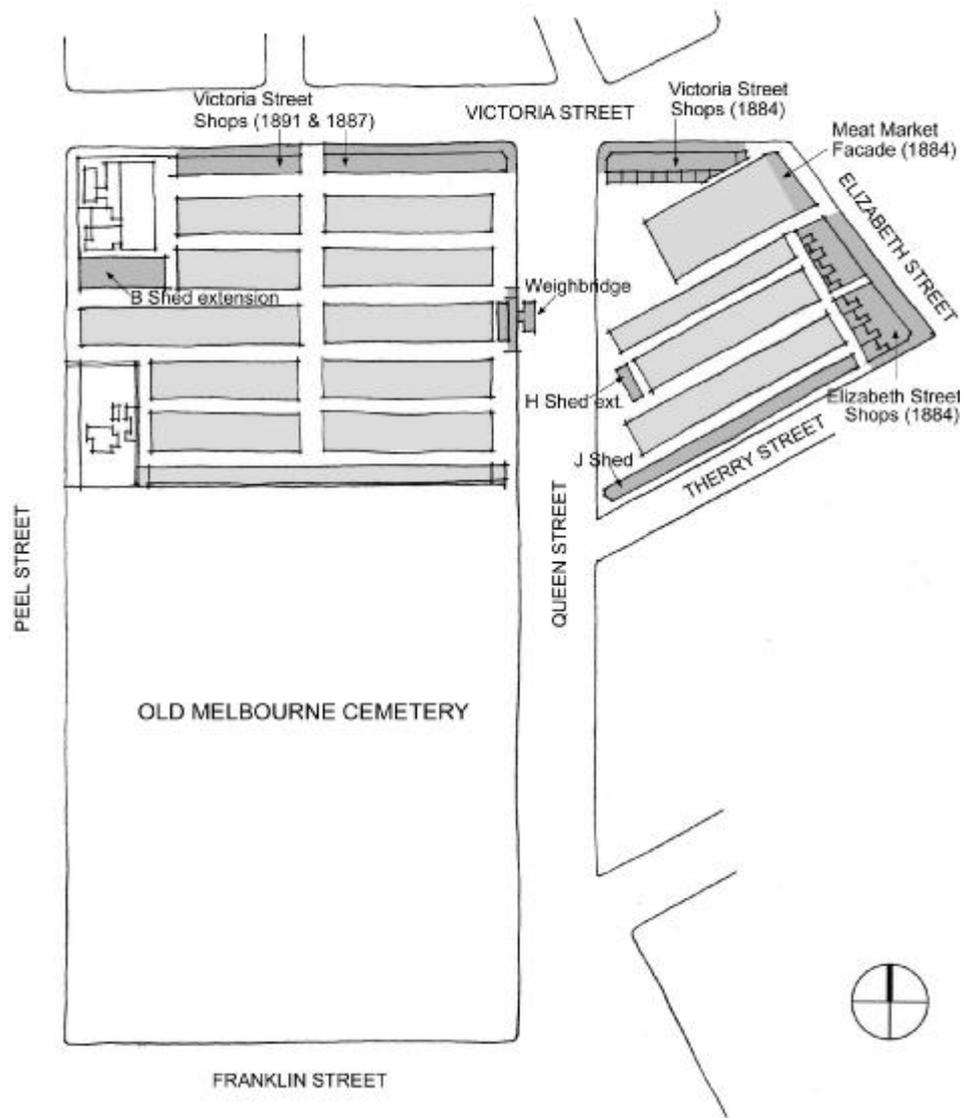
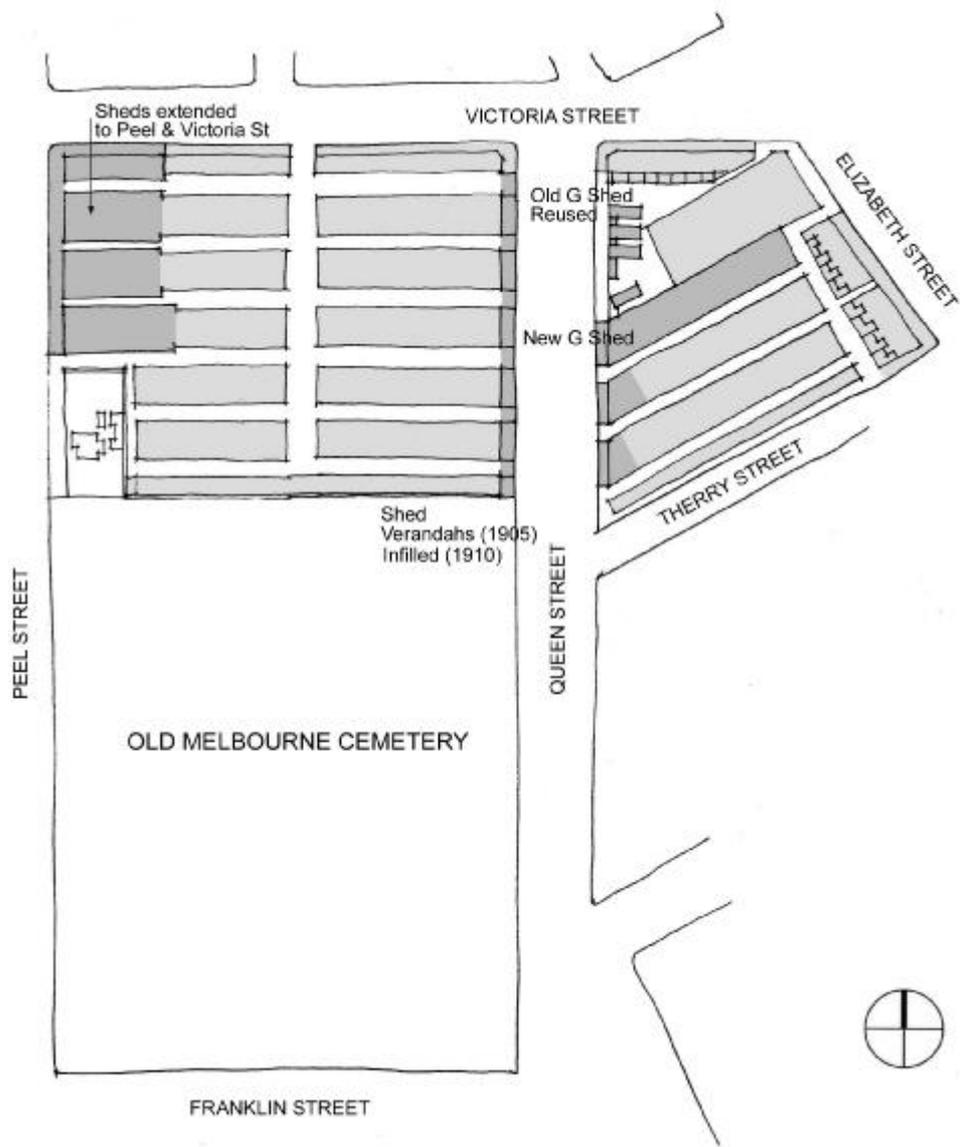
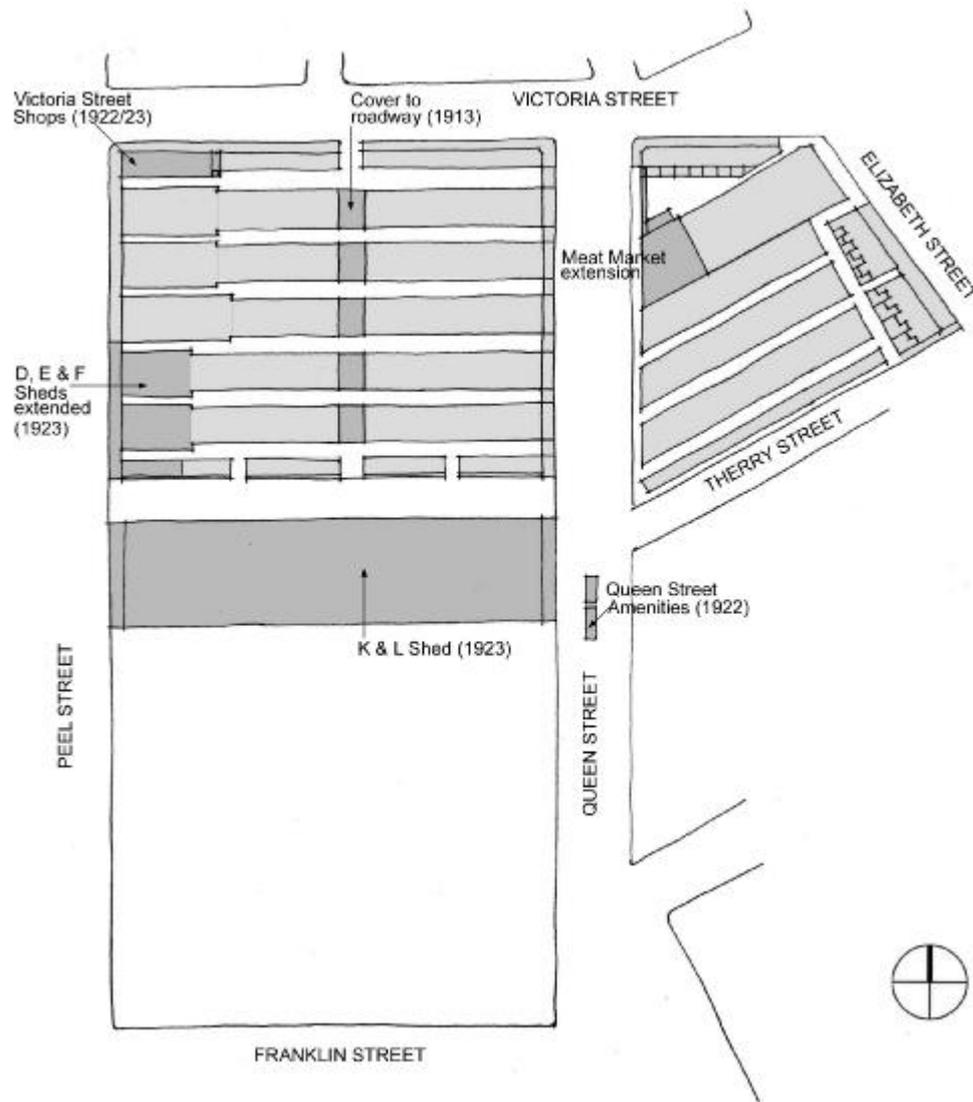
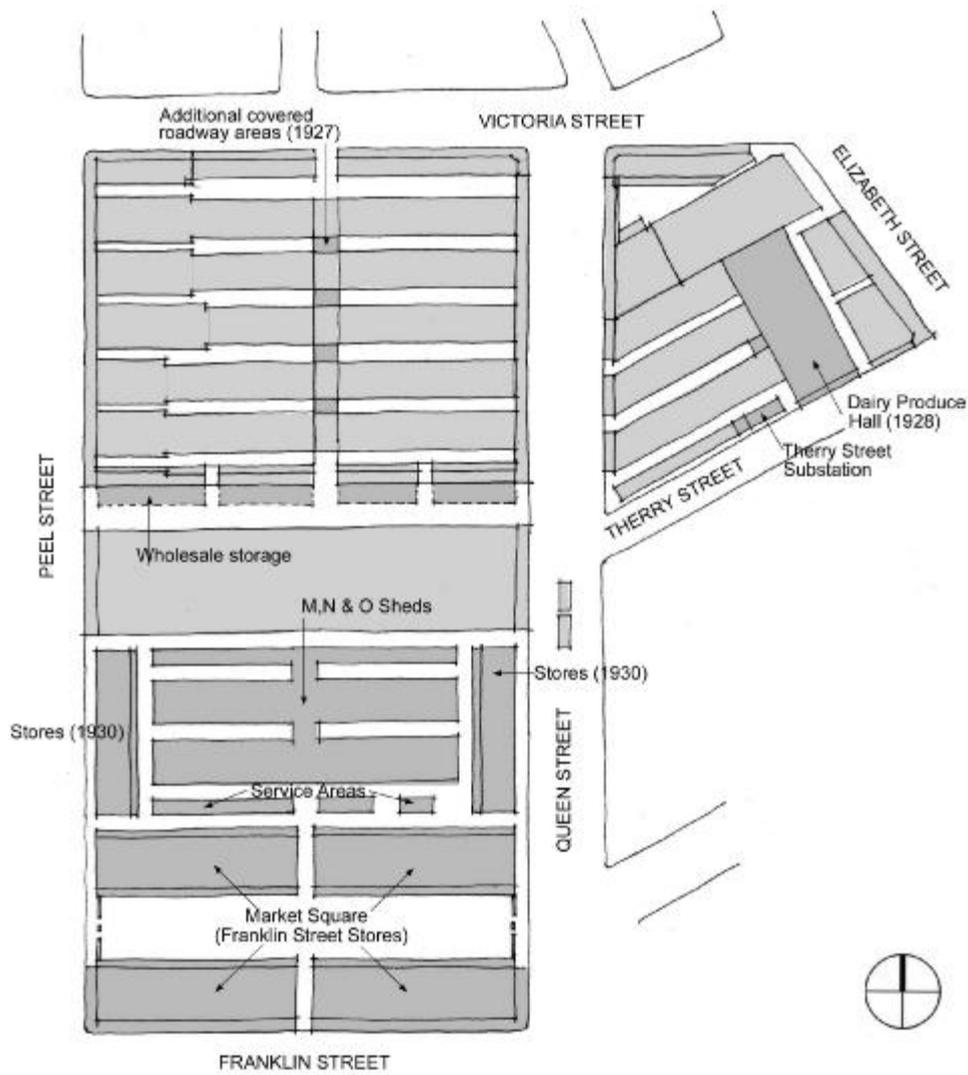
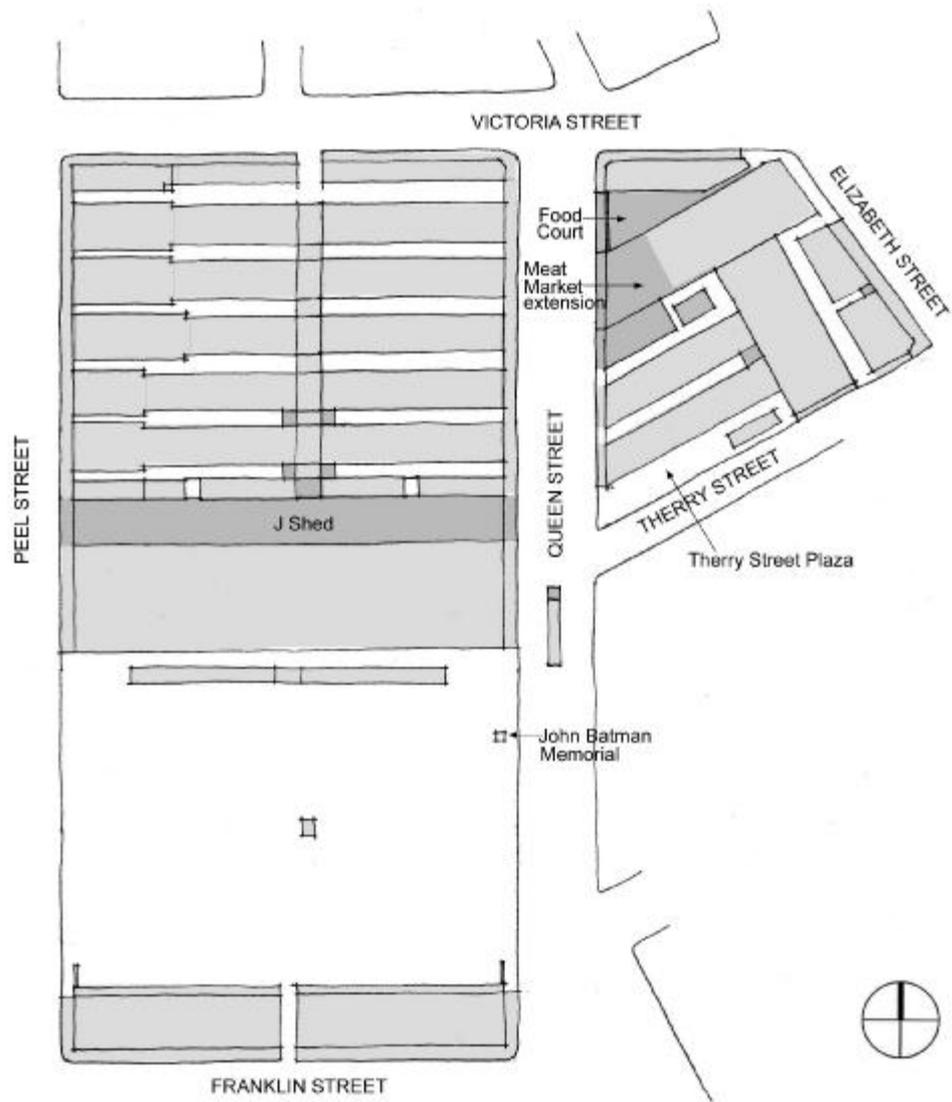
The above history of the development of market structures is illustrated in the following plans of the market site (Figure 20 to Figure 26). New buildings of each period are shaded in dark grey.

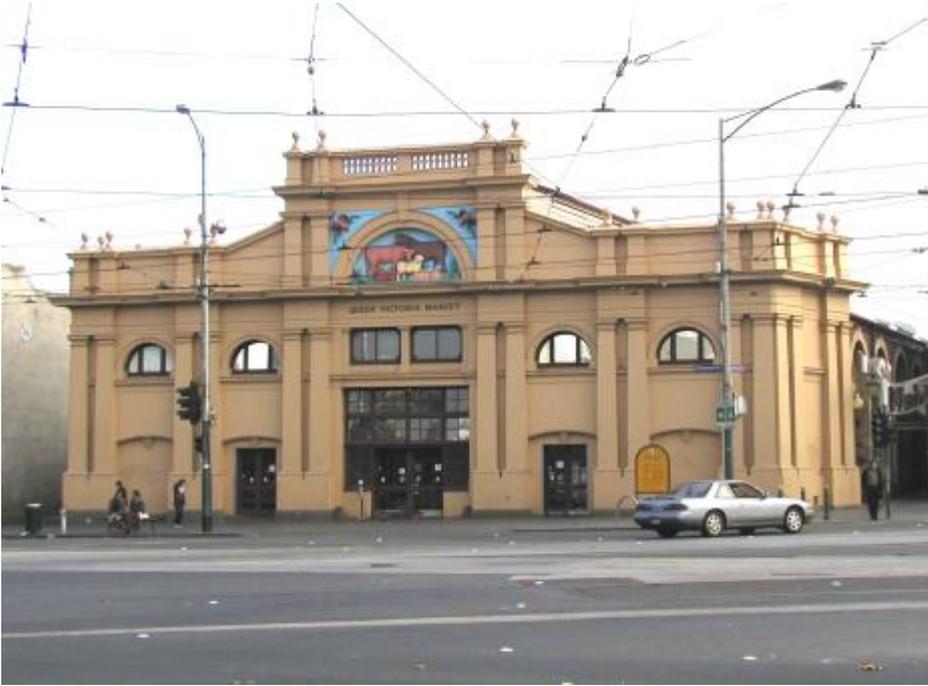
Figure 27 Meat Market, Elizabeth Street elevation.

The north-east elevation (Elizabeth Street façade) is predominantly intact in form and fabric to its 1884 date of construction, with the exception of some minor alterations including non-original paint finishes, the bricking in of the two outer doorways, glazed entry doors and repairs to render. The multi-paned sash windows above the recent entry doors are non-original, but would appear to have been added at an early date.

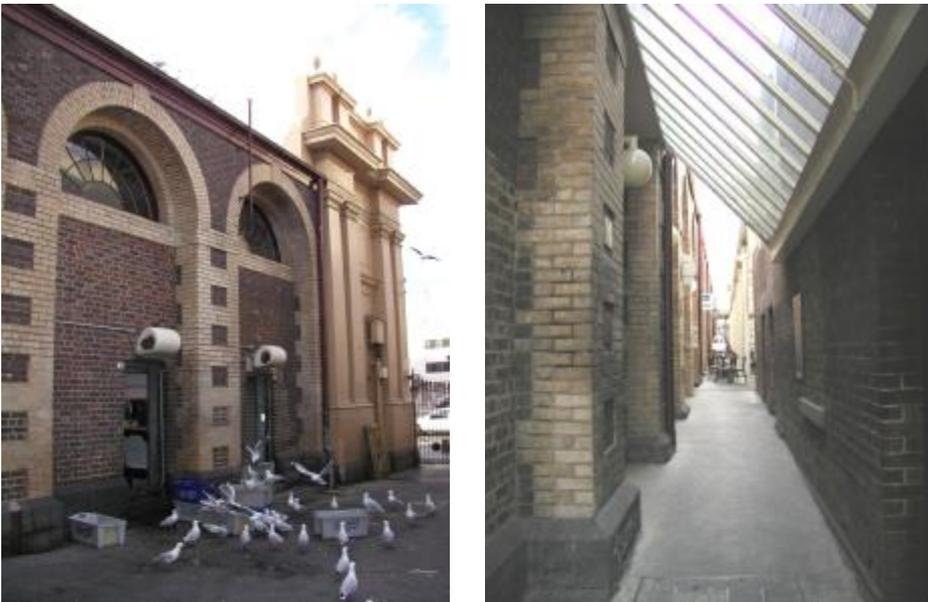
Figure 28 Meat Market, south-east (left) and north-west (right) elevations

The arched north-west and south-east elevations are substantially intact in plan form and fabric to their 1869 date of construction, despite a number of minor alterations. Changes include the bricking in of some existing door openings and the creation of new door openings in others; the installation of modern wall mounted spherical lighting and gas heaters along the north-west elevation to the food court and corridor; and replacement of the majority of timber fascias and steel gutters. New brickwork readily identifies the addition.

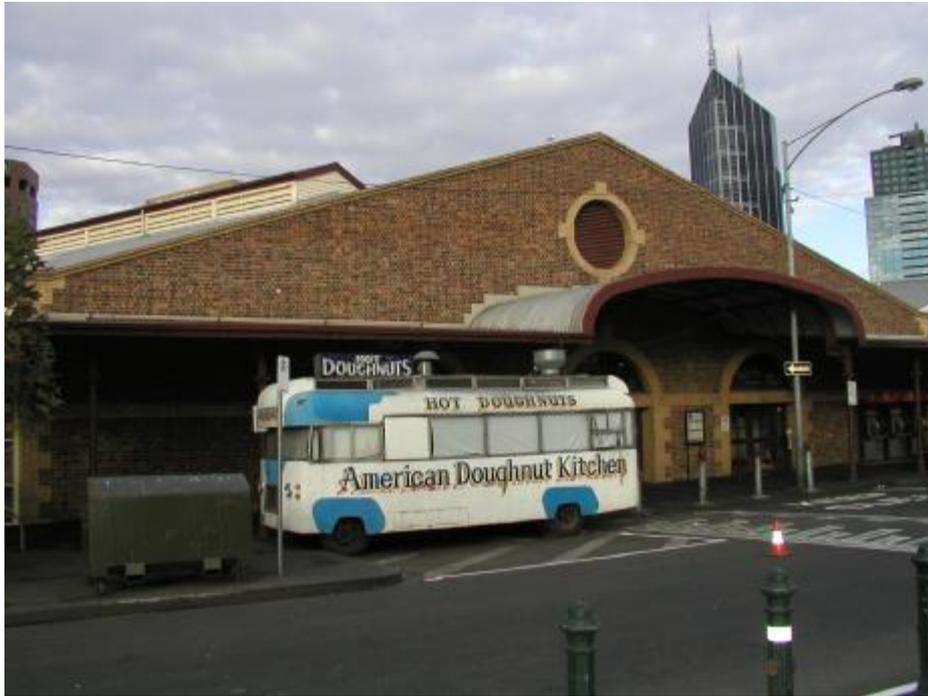
Figure 29 Meat Market, Queen Street elevation

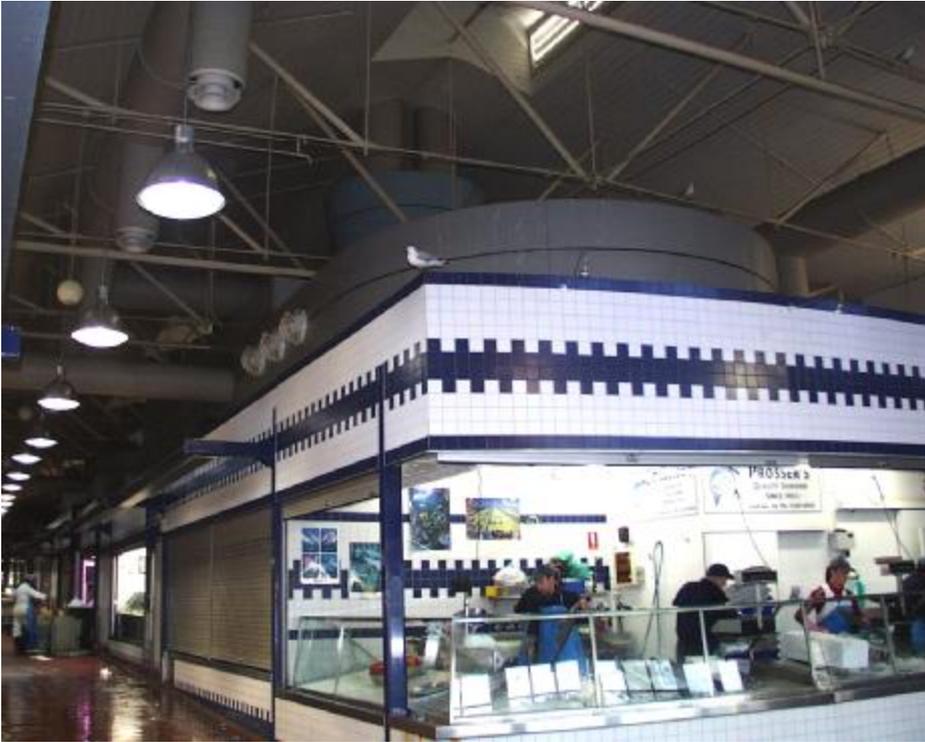
Figure 30 Meat Market interior illustrating recent stalls within the 1869 form of the hall

The Meat Market has generally been well preserved, however repairs to and reconstruction of brickwork have been poorly carried out with irregular pointing. Likewise, conspicuous wall-mounted light fixtures within the Food Court and corridor to Elizabeth Street have been installed.

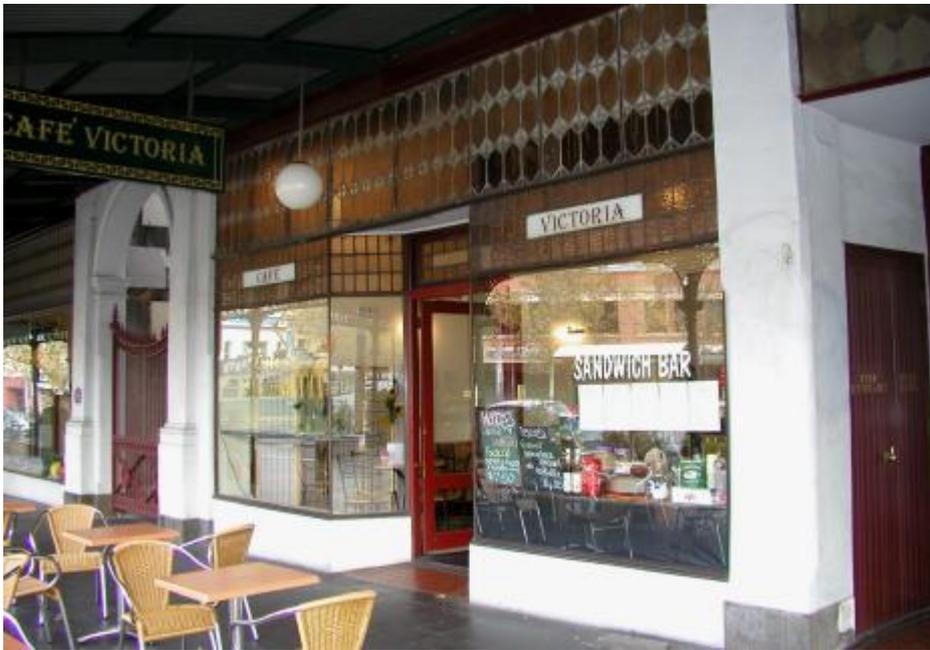
Figure 32 Edwardian leadlight shopfront, 517 Elizabeth Street

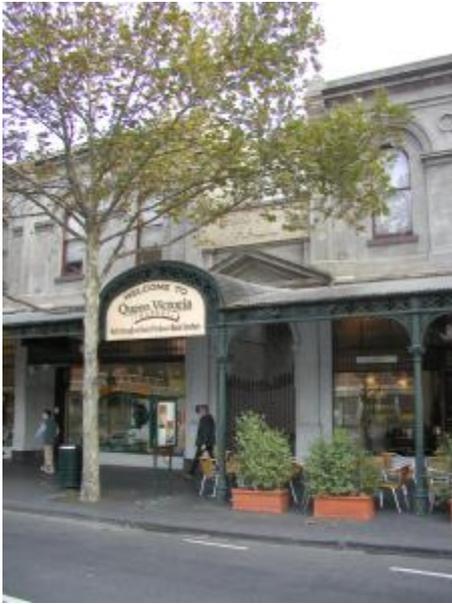
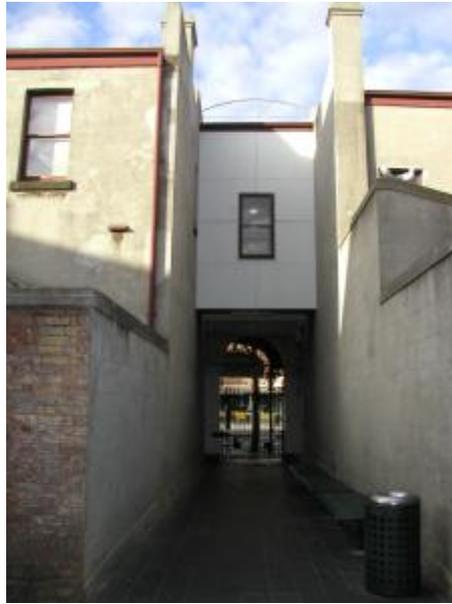
Figure 33 Produce Hall arch from Elizabeth Street (left) and rear lane (right)

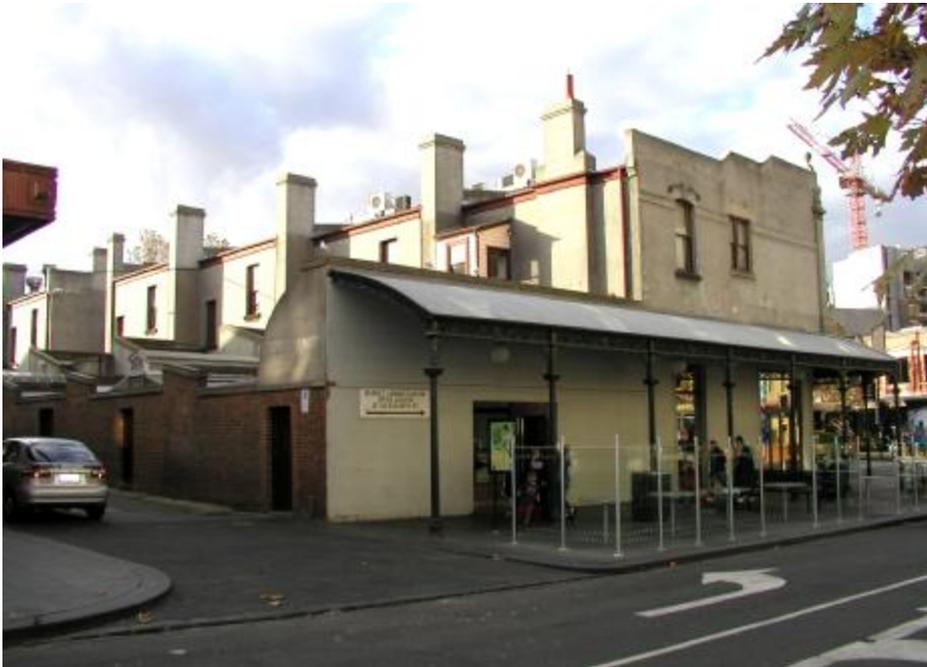
Figure 34 Rear yards, 507-523 Elizabeth Street.

Non-original shop fronts at ground floor level contain timber-framed fixed display windows. The cast iron verandah, which extends the full width of the elevation, matches that on the front elevation.

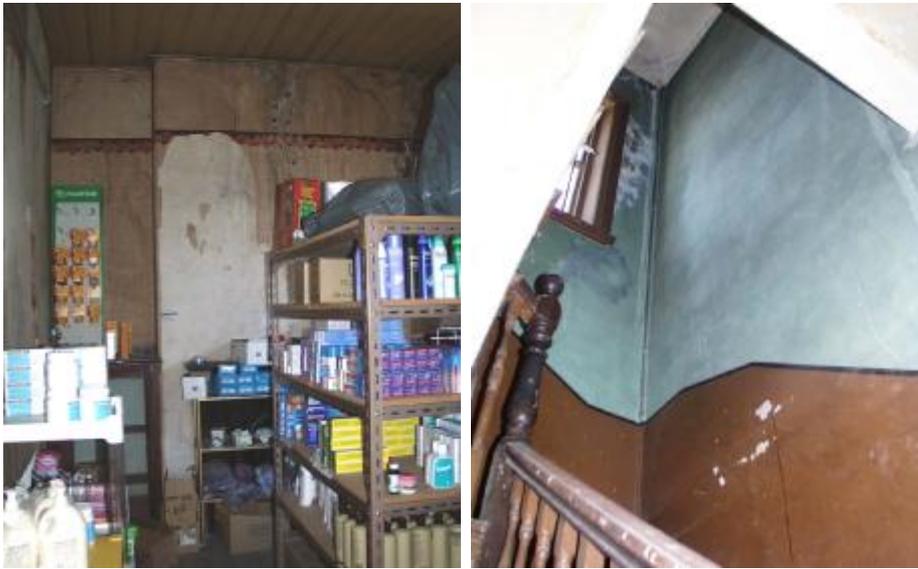
*Figure 35* Substantially intact interiors, 523 Elizabeth Street

The ground floor level floors, originally constructed of timber flooring over timber framing, have been variously replaced by concrete slabs. Modern finishes exist throughout the building including carpet, tiles and vinyl. The first floor level floors are constructed of traditional timber framing lined with Baltic pine boards and generally have recent carpet finishes. The only remaining first floor bathroom area is finished with vinyl flooring over lead lining. Refurbished bathrooms are lined with recent vinyl flooring. The floors are generally finished against the walls with typical Victorian profile moulded timber skirtings, with the exception of the area beneath the stairwell which contains a small rectangular profile. Original interior walls include solid brick dividing walls between terraces, stairwells and rear rooms which are finished with hard plaster. Timber-famed partition walls are lined with lathe and plaster in all other areas. The bathroom in No. 517 is lined with mini-orb corrugated galvanised steel and timber lining boards.

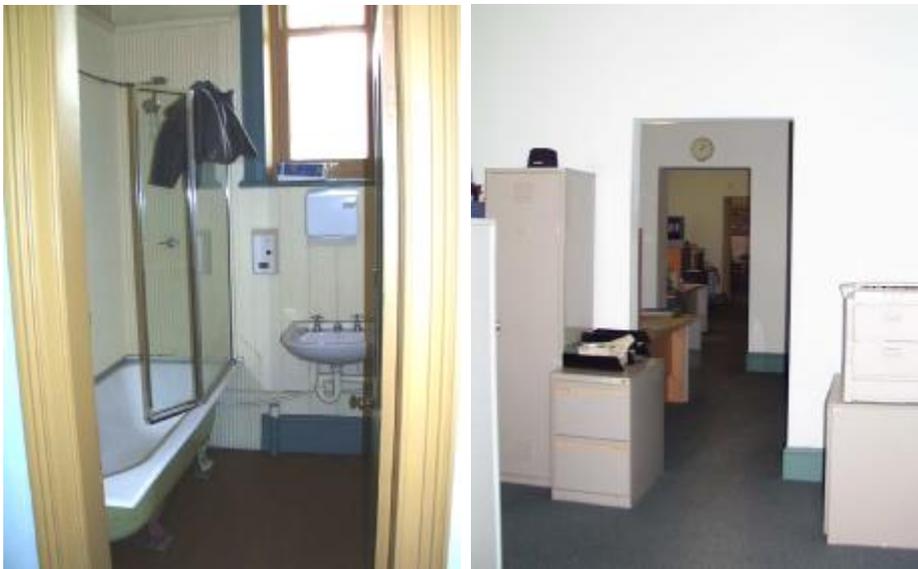
*Figure 36* Early first floor bathroom, 517 Elizabeth Street (left) and new interconnecting openings, first floor (right)

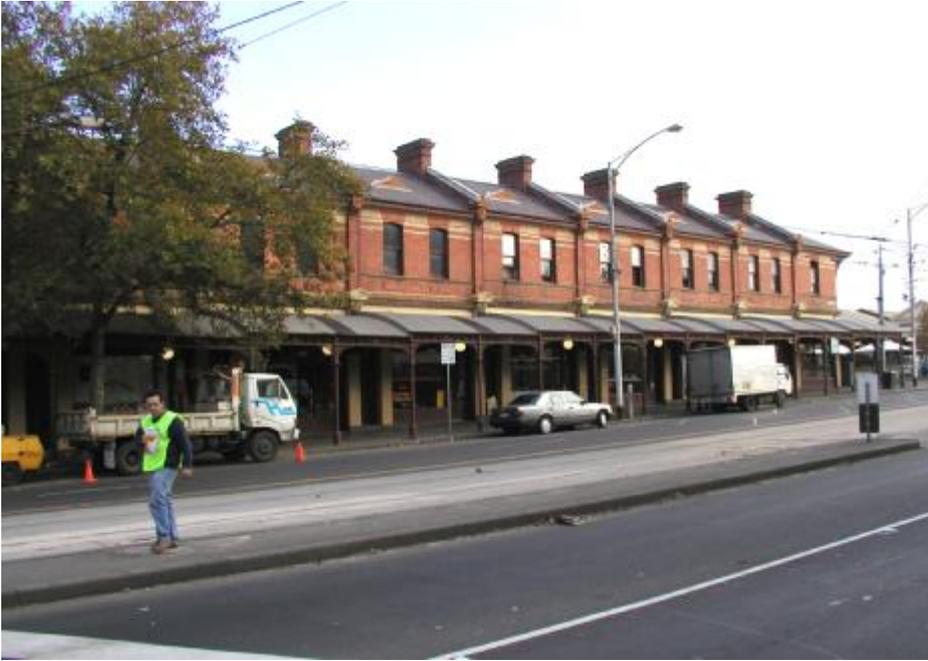
Figure 37 The principal north (Victoria Street) elevation.

The principle façade is picturesque in composition yet lacking in typical Victorian detailing of the period. The row is divided vertically into nine bays by brick pilasters which are corbelled at the eaves line and finished with a carved stone console. The floor levels are delineated horizontally by a wide, corbelled cream brick string course. The string course features carved stone consoled and pedimented corbels embellished with carved Melbourne City Council crest motifs where it crosses each pilaster. The ground floor is further distinguished by a rubbed Stawell stone facing (now overpainted) to the pilasters and storeboards. Bands of cream brick of varying widths contrast with the face red brick at first floor level and a corbelled cream brick band finishes the façade with the underside of the eaves overhang.

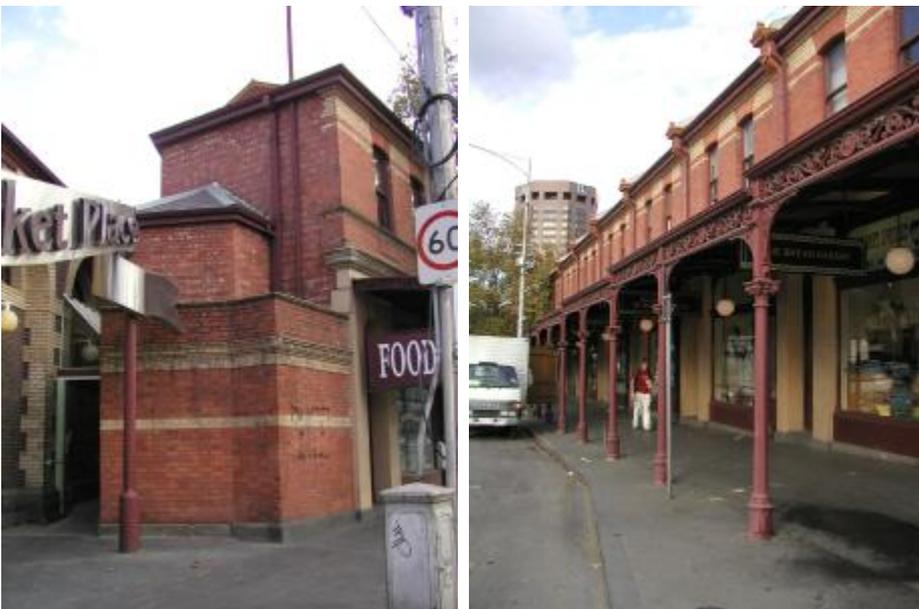
Figure 38 East elevation (left) and Victoria Street verandah detail (right)

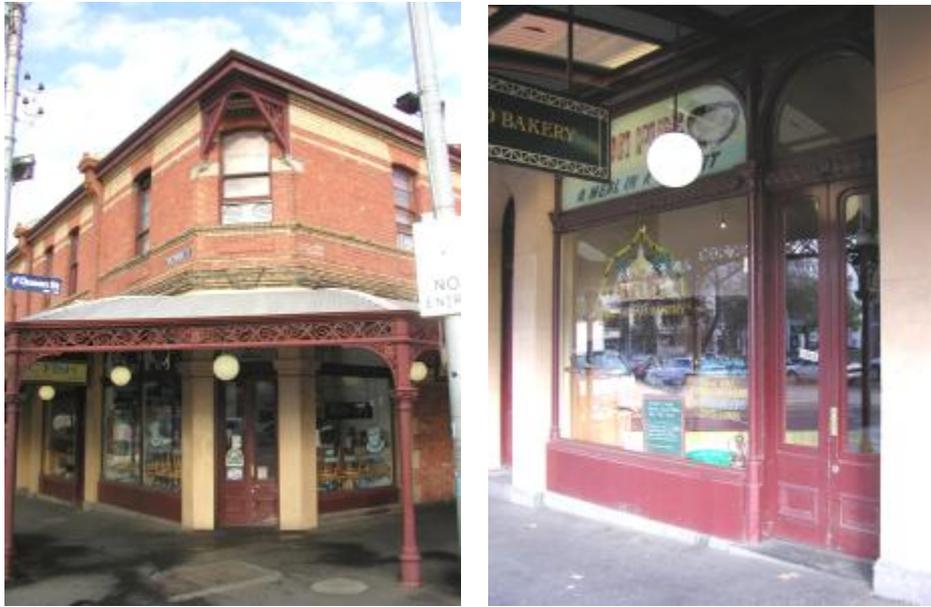
Figure 39 Splayed north-west corner (left) and typical shopfront (right)

Fenestration is regular and repetitive and, with the exception of the terrace at the western end (No. 81), each bay contains a pair of segmental arched, timber-framed, double-hung sash windows at first floor level. Each of the openings is expressed by a bold red brick soldier arch and rendered brick sill, while cream brick string courses extend between the windows at impost and sill level. Beneath each window is a small raised panel of brickwork. The north elevation of No. 81 contains only one window opening, a second being located on the splayed corner. This corner window is finished with a distinctive canopy formed by the projecting corner of the roof, which is supported by ornately carved timber brackets bearing on carved stone corbels.

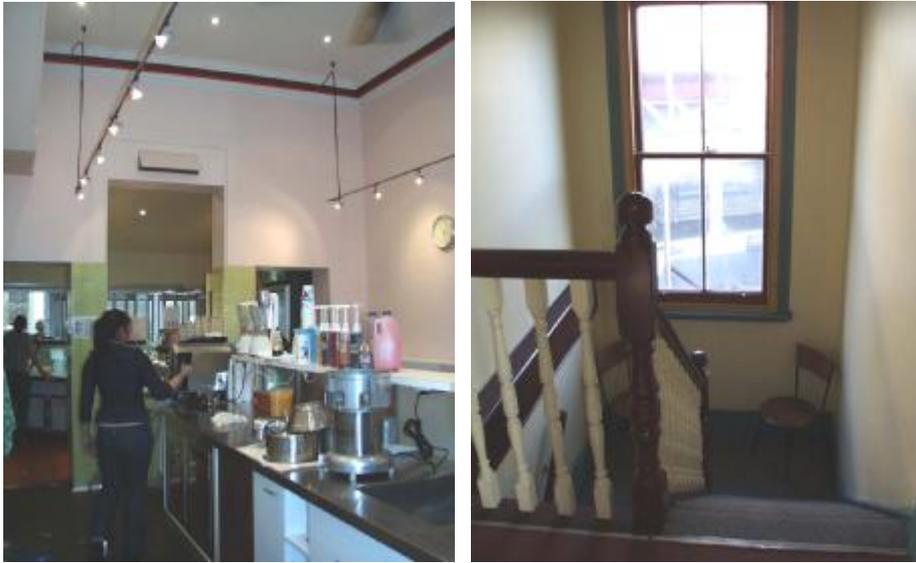
Figure 40 Altered ground floor, No. 75 (left) and refurbished stairwell, No. 69(right)

- No. 69      Ground Floor: wall removed between rooms; kitchen fit-out  
First Floor: Refurbished; door leaves reconstructed; WC cubicle
- No. 71      Ground Floor: Intact ceiling; some skirtings replaced; wall removed between rooms; kitchen fit-out  
First Floor: Refurbished; sitting room fireplace reconstructed

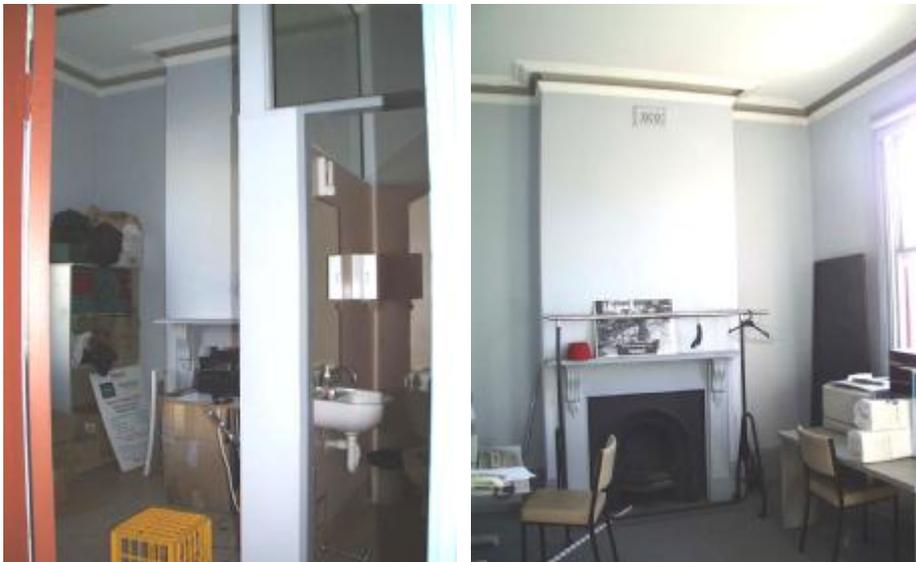
Figure 41 Typical WC installation (left) and refurbished first floor front room (right)

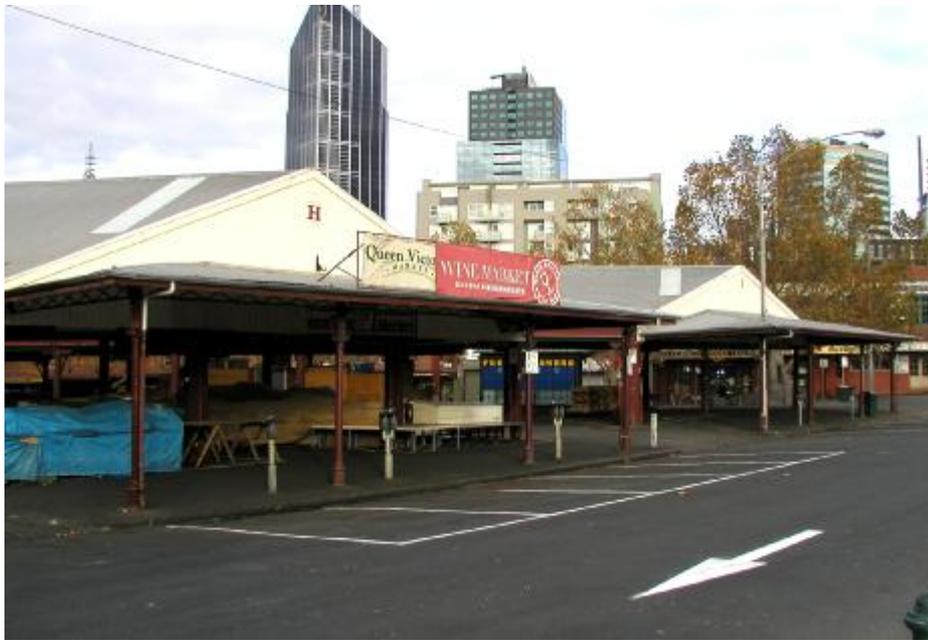
Figure 42 Queen Street elevation, H & I Shed

The shed floors are finished with recent asphalt and screened by recent retractable canvas awnings and blinds. Each shed is screened at the western (Queen Street) end by a skillion roofed verandah on standard City of Melbourne cast iron verandah with trellis beams.

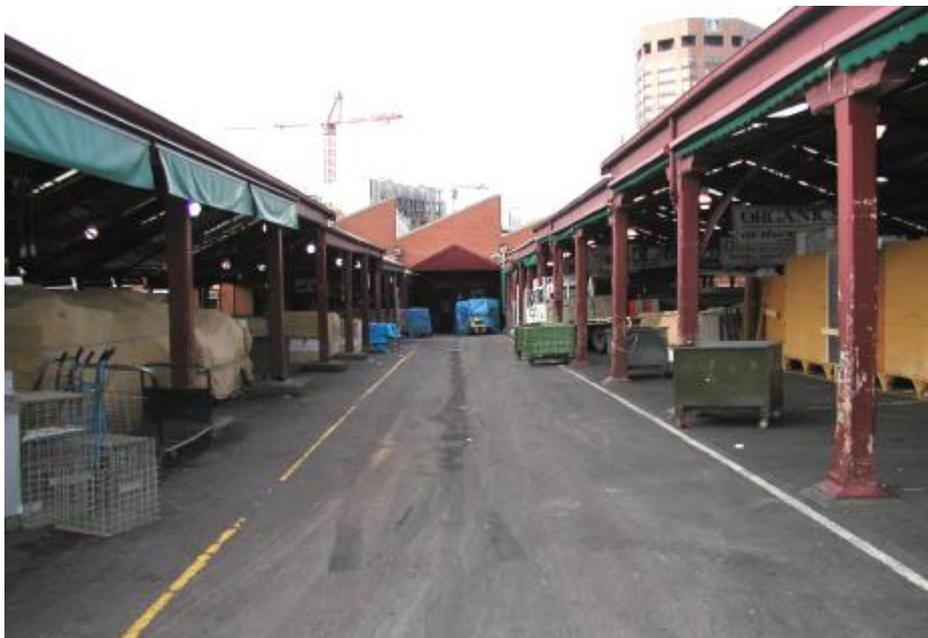
Figure 43 Central roadway, H & I Shed

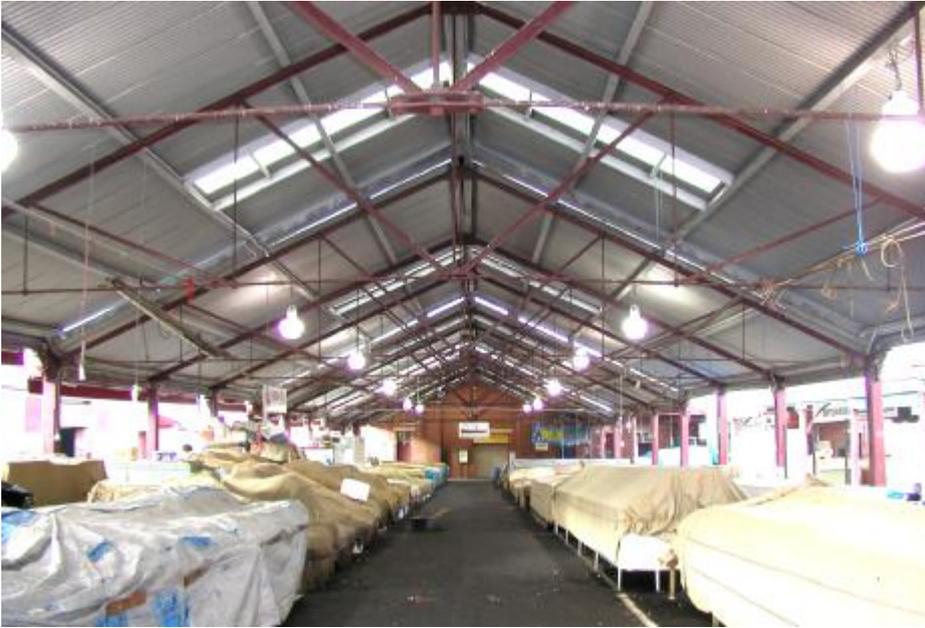
Figure 44 Interior, H Shed

The junctions of the posts and beams in H Shed are finished with decorative cast iron brackets whereas I Shed posts support profiled timber shear heads like those on Sheds A-E. All posts and beams are finished with a simple stop-chamfered detail.

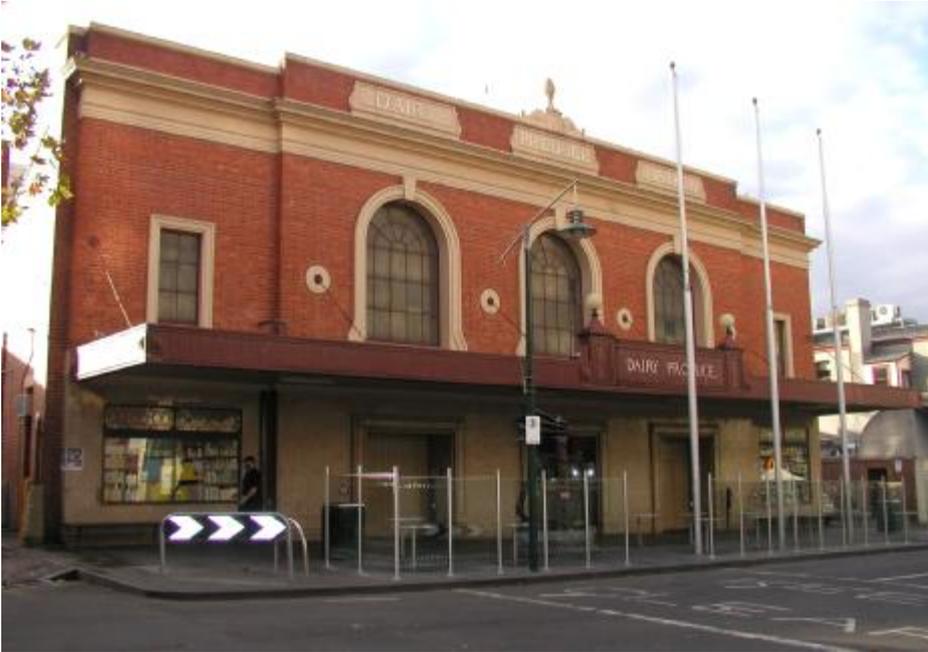
Figure 45 Dairy Produce Hall, Therry Street elevation

The exterior of the Dairy Produce Hall has undergone few alterations since its construction in 1928. Changes have been relatively minor and are limited to the recent retractable awnings fixed to the southern bays of the north-east elevation; replacement of the original asbestos roof cladding; replacement of the original timber-framed entrance and side doors; replacement of original awning soffit lining; removal of a small number of fanlight windows for the installation of air-conditioning units; and the installation of lighting and surface-mounted service conduits.

Overall, the exterior of the Dairy Produce Hall is in good condition.

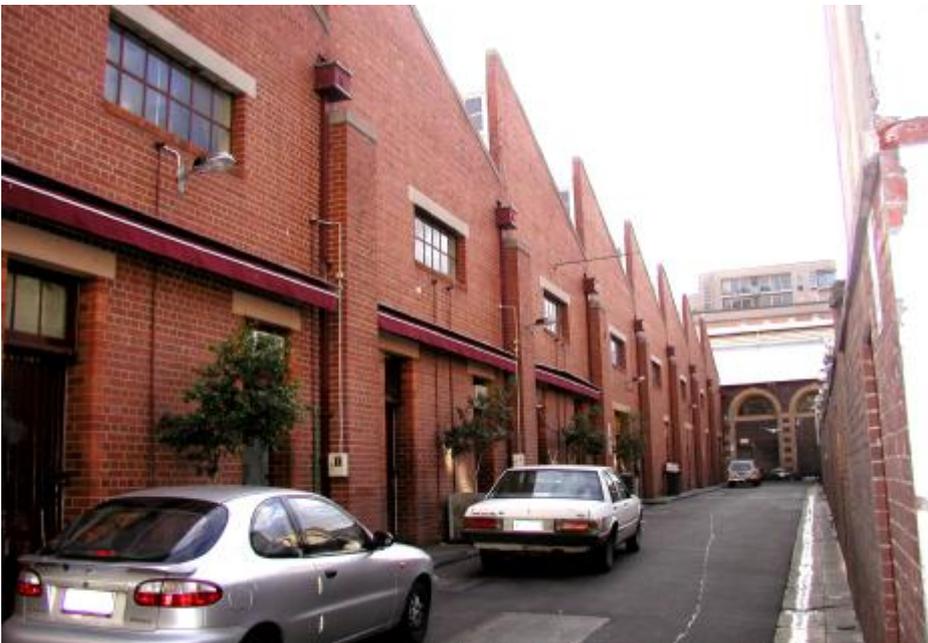
Figure 46 Dairy Produce Hall, south-east elevation

At first floor level of the north-east elevation each bay contains a wide steel-framed multi-paned fixed sash window. Each bay also contains a surface-mounted decorative galvanised steel rainwater head which drains to a part galvanised steel, part cast iron downpipe. In addition, the three southern-most bays on the north-east elevation are screened by recent retractable awnings. The south-west elevation is obscured by the extension of H and I Sheds and covered way.

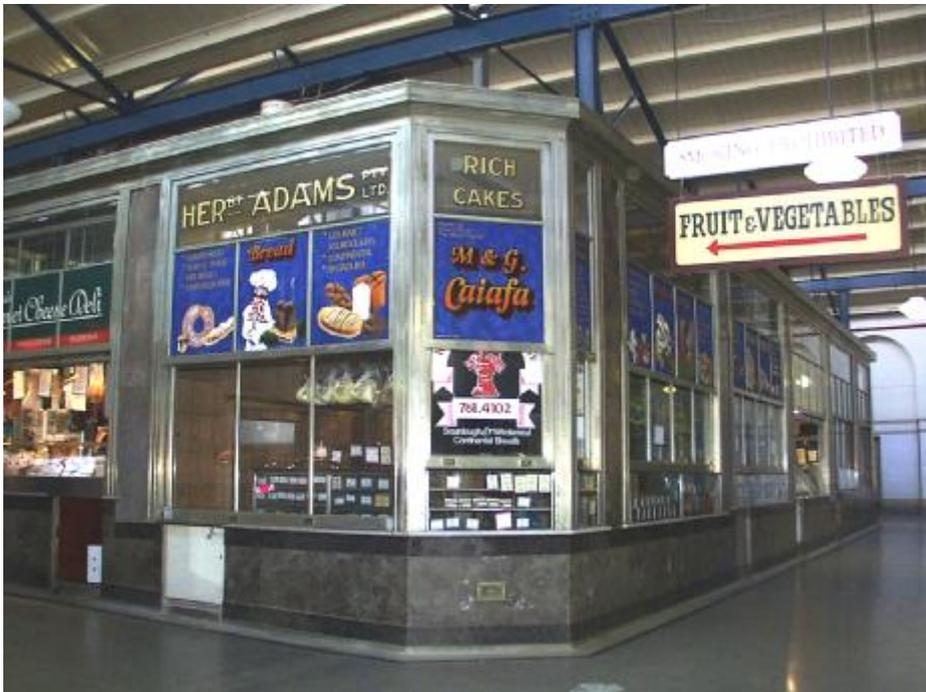
Stall shopfronts are nickel silver-sheathed timber-framed construction. The interior of the frames are painted with metallic silver paint to match. Vertically balanced sash shutters are complemented by fixed sashes of bevelled glass bearing signage and decorative cornices. Original infill panels of interlaced nickel silver strapping have been replaced with glazing.

*Figure 47 Typical corner stall, Dairy Produce Hall*

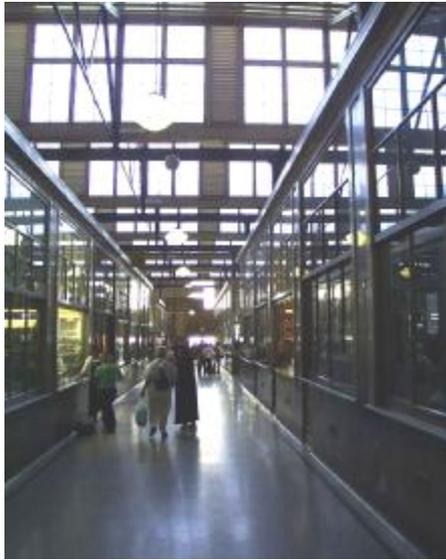
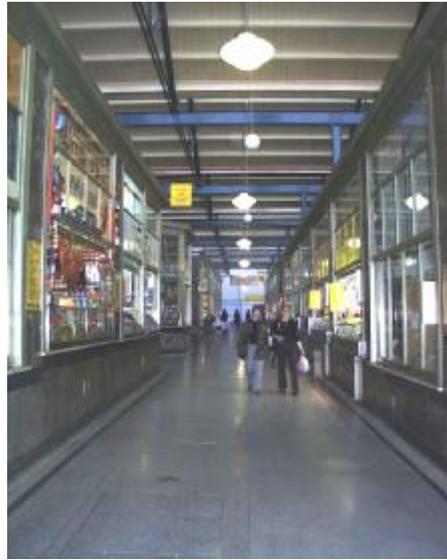
*Figure 48 Main aisles, Dairy Produce Hall, looking south (left) and north (right)*

The main Dairy Produce Hall ceiling is lined with painted timber tongue and groove lining boards fixed to the timber purlins. The original wire mesh-cladding to stall ceilings has been replaced with modern plasterboard lining.

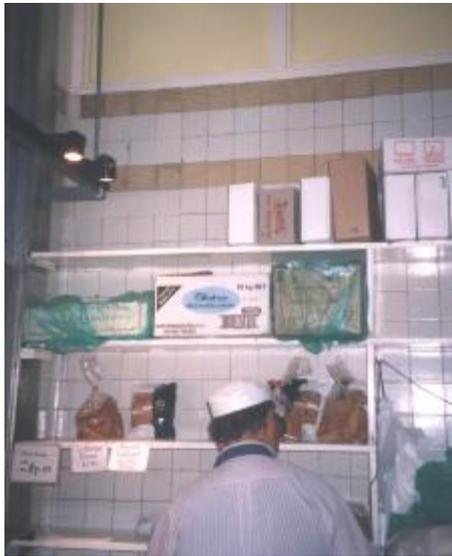
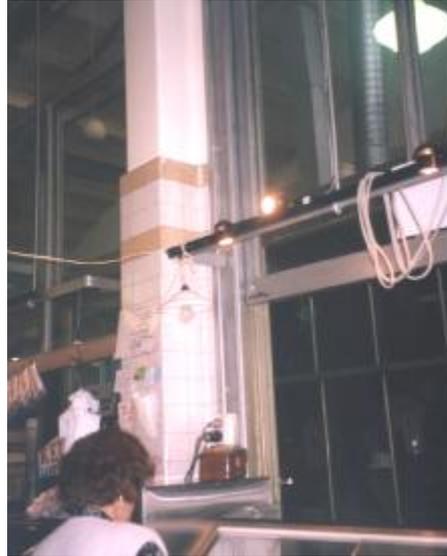
*Figure 49 Dairy Produce Hall stall interiors*

The interiors of the individual stalls have been fitted out by stall holders and generally involve similar alterations. These generally include a small cool room, timber shelving on metal strip brackets, glazed refrigerated counter-top display cabinets and some form of raised platform over the original floor. In addition, stainless steel basins and sinks have been installed by the tenants. The condition of the individual stalls varies, however a number of stalls have cracked marble counter-tops, stained tiles and counter-tops, damaged metal sheathing to timber-framing and repairs to wall tiling.
