# QUEEN VICTORIA MARKET

ELIZABETH STREET, MELBOURNE  
CONSERVATION MANAGEMENT PLAN

**QUEEN VICTORIA MARKET PTY LTD**

April 2003

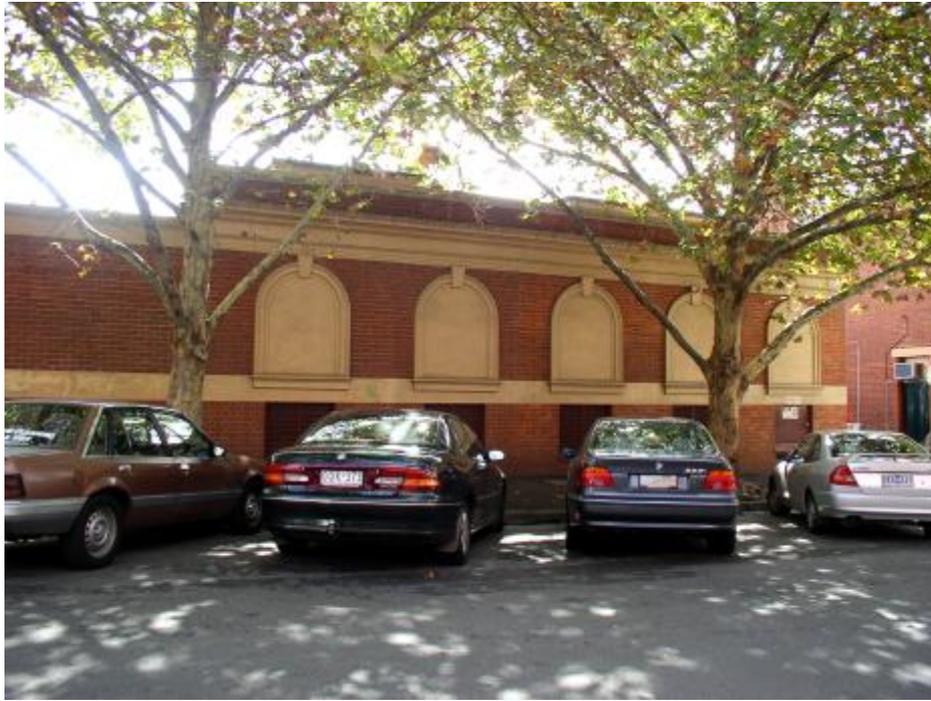
The north elevation is more utilitarian with three wide openings containing timber-framed doors above which is a rendered concrete lintel which is continuous around three sides of the building.

Figure 50 Therry Street Sub Station

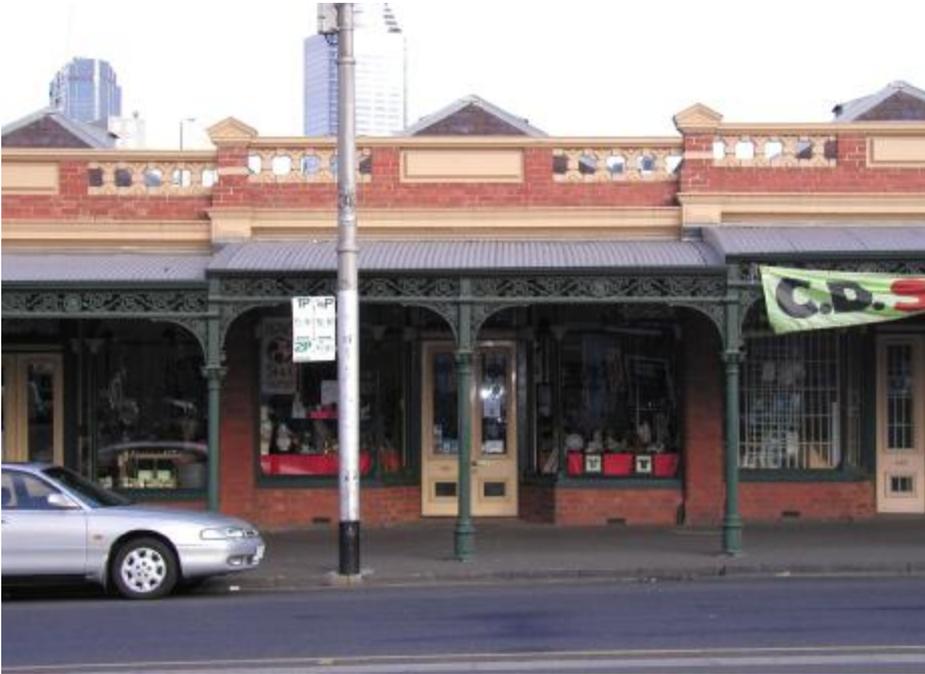
Each bay contains a wide central entrance flanked by a pair of window openings, all with segmented arch heads and cream brick dressings. Fenestration is regular and repetitive. Each entrance contains a pair of timber-framed sliding doors with diagonally fixed V-jointed lining boards screened by a pair of non-original timber-framed fully-glazed doors. Window openings contain a single timber-framed casement sash window and solid timber panelled shutter. A recent retractable canvas awning screens each shop at eaves level.

Figure 52 Typical group, Victoria Street shops, north elevation

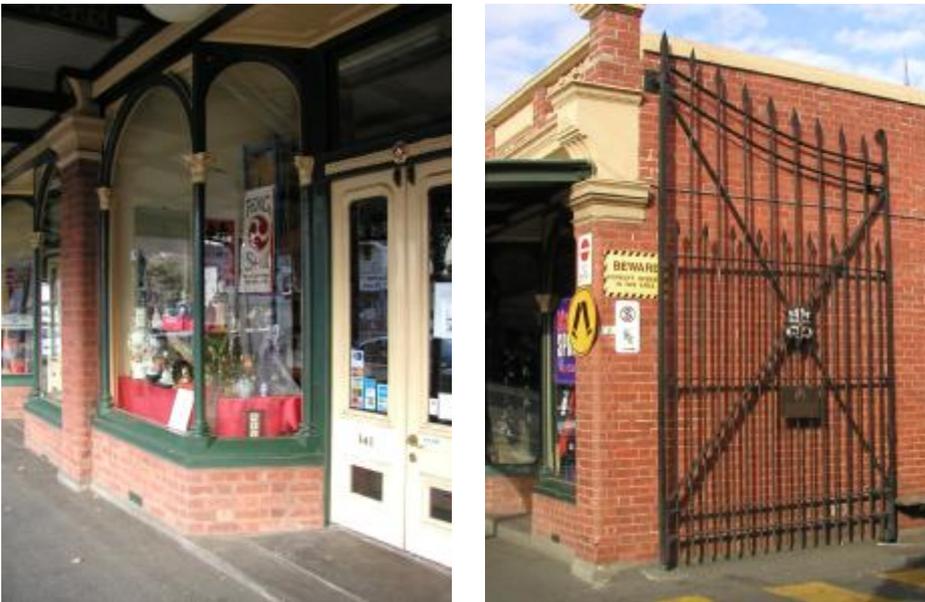
Figure 53 Typical shopfront detail (left) and cast iron gates from the Hay Market (right)

Modern external lighting, canvas awnings, signage and service conduits have also been affixed to the building. A pair of c.1874 wrought iron gates from the Melbourne Haymarket were installed in their present position between the 1880s rows of shops in 1992 (Figure 53).

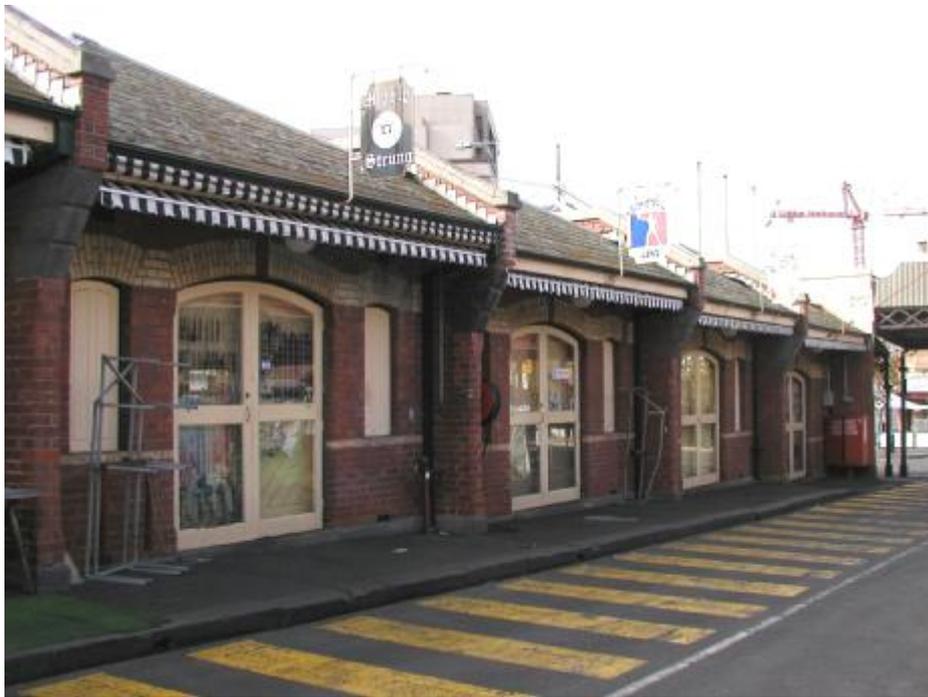
Figure 54 Rear elevation, Victoria Street shops, Upper Market site

Unlike the 1880s buildings the south elevation of the 1920s row is more utilitarian in nature. The face red brickwork is relieved by a wide rendered band at lintel level and divided vertically by pilasters between tenancies and flanking entrances. Each entrance contains non-original timber-framed fully-glazed doors and fanlights. A pair of high level windows flank each entrance and contain timber-framed tripartite fixed sashes.

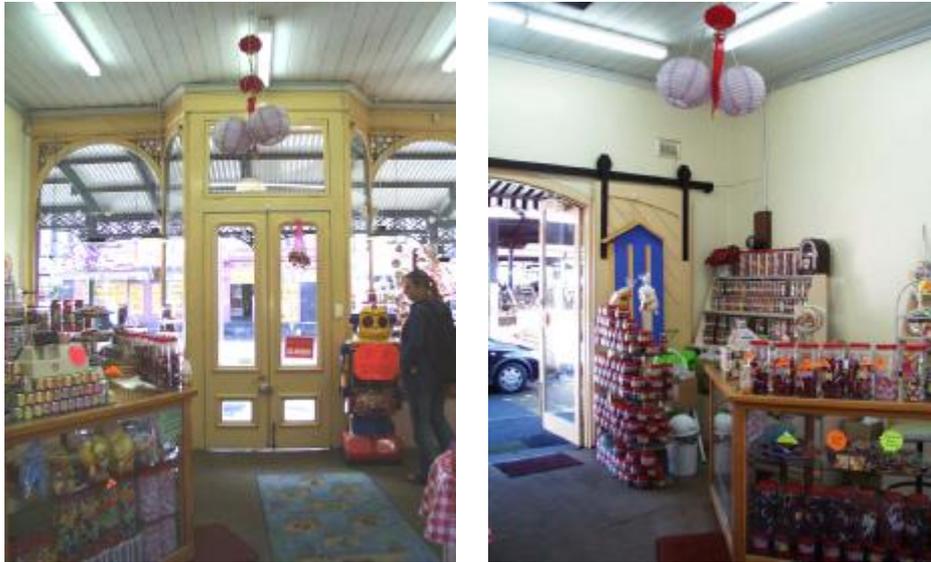
Ceilings throughout the buildings are lined with beaded timber lining boards with a paint finish. In the case of the 1880s building, the ceilings are flat and feature timber ceiling roses and cornices. With the exception of No. 157-159 which has a modern suspended ceiling, the 1920s ceilings are raked and finished with beaded timber lining boards, scotia cornices and exposed angle-iron trusses.

Figure 55 Typical shop interior, 87-89 Victoria Street

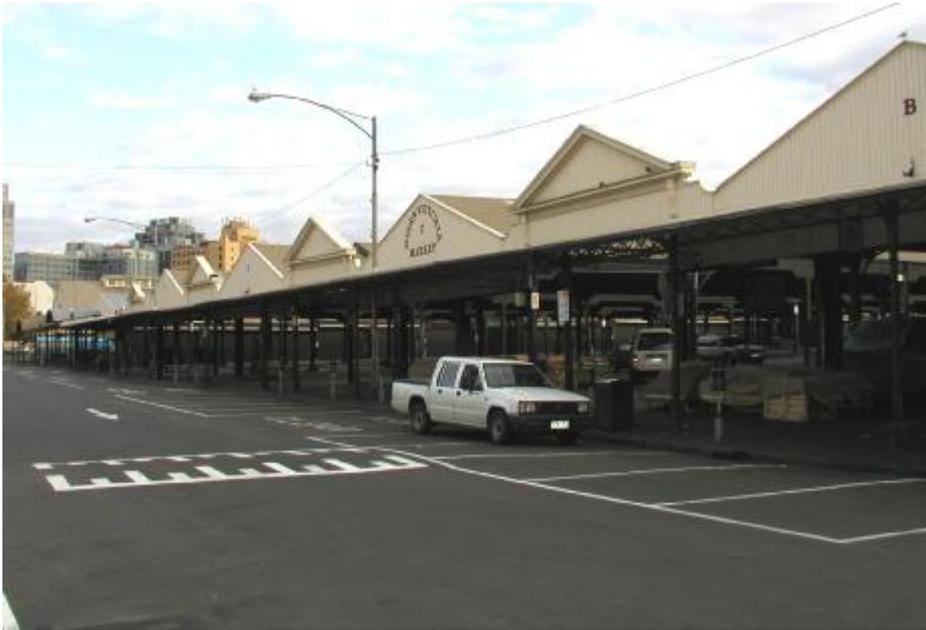
All sheds are 506 feet (154.3 metres) in length and 48 feet (14.65 metres) wide and consist of a wrought iron-framed gabled roof supported by timber post and beam construction.

*Figure 56 Sheds A-E, east elevation, Upper Market*

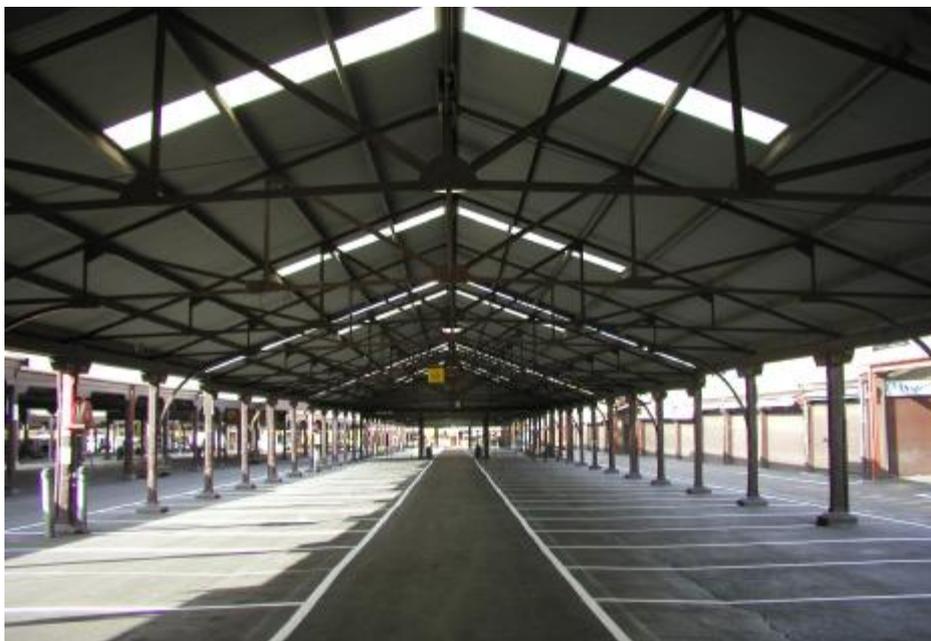
Figure 59 *Shed interior, E Shed*

Initially divided by a roadway through the approximate centre of the sheds, the individual sections of each shed were later linked by a roofed infill. This infill was later extended to link all five sheds.

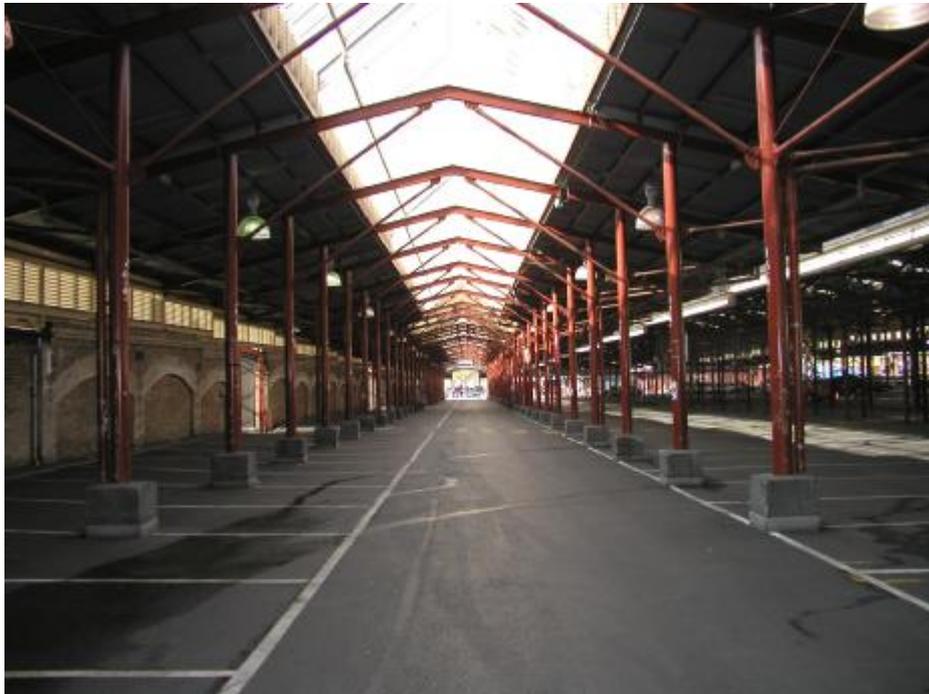
The columns support a symmetrical pin jointed roof frame. Constructed of steel sections, a gabled truss spans the centre aisle and overhangs the side aisles. This main roof form is clad with corrugated galvanised steel.

Figure 62 Interior view looking east, New J Shed

In addition, a wide steel-framed roof lantern is located over the centre aisle. The lantern gable ends and highlights are filled with bays of powdercoated steel louvers and the roof is glazed with clear polycarbonate roof sheet. The skillion and segmented arch verandah roofs are clad with corrugated galvanised steel.

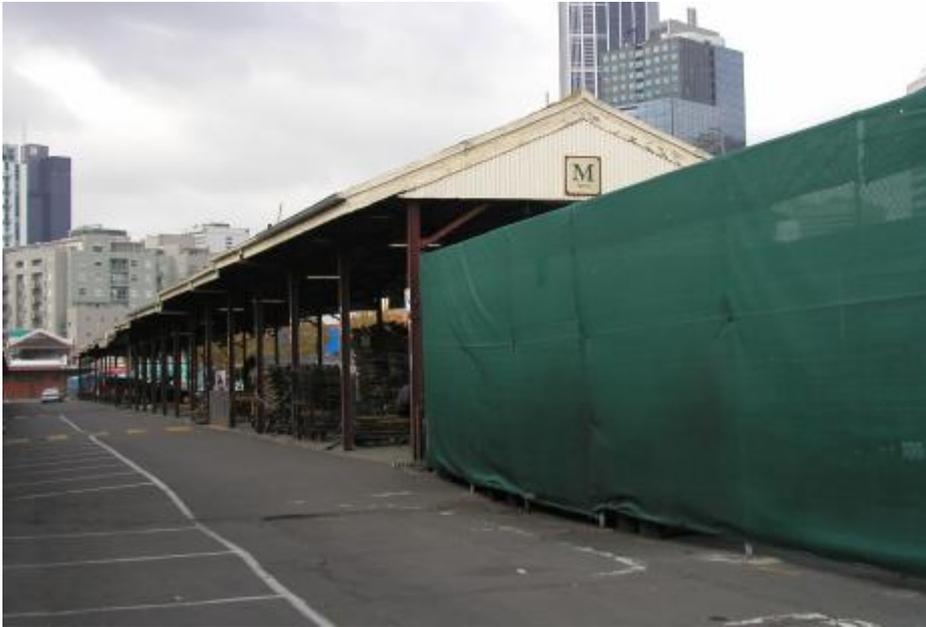
M Shed consists of two sections which are divided into structural bays by regularly spaced steel I-section columns. The columns extend through the paving level to reinforced concrete pad footings. With the exception of the original covered link, each column extends to a rigid connection with the roof truss. The covered link section varies in that the trusses are supported by a steel I-section beam, enabling a greater distance between columns. Crude steel bollards and barriers have been constructed between the columns in some instances. The shed ends are finished with corrugated asbestos sheet cladding to the gable ends.

Figure 65 M Shed, north-east elevation

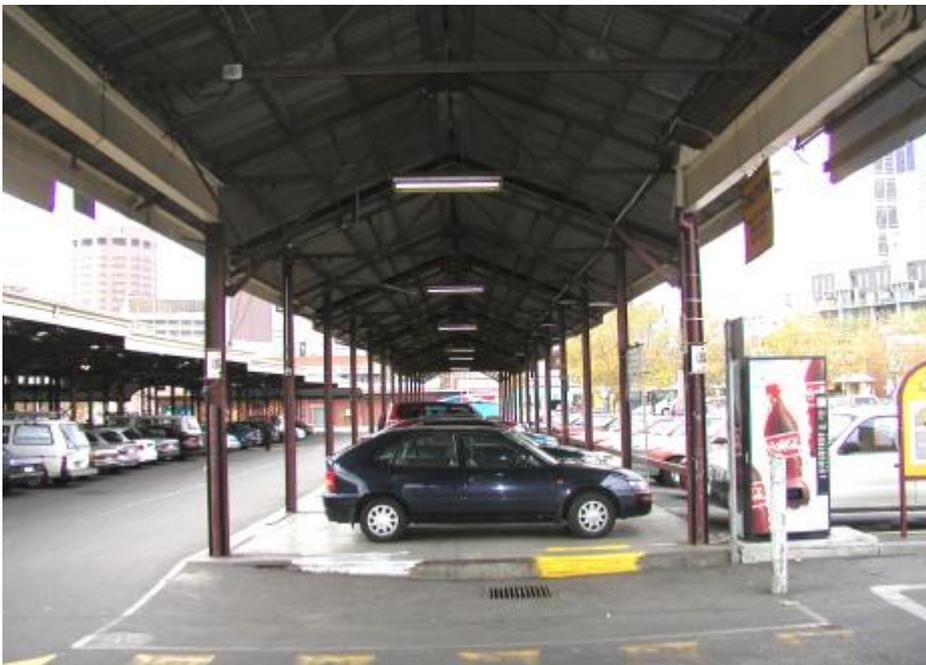
Figure 66 M Shed, interior view looking east

A variety of light fittings and services suspended from the shed roof includes enamelled steel pendant lights, modern fluorescent lights, early wiring and recent fire services. Recent signage is fixed beneath the covered roadway.

M Shed is essentially intact to its date of construction, although is in poor condition.

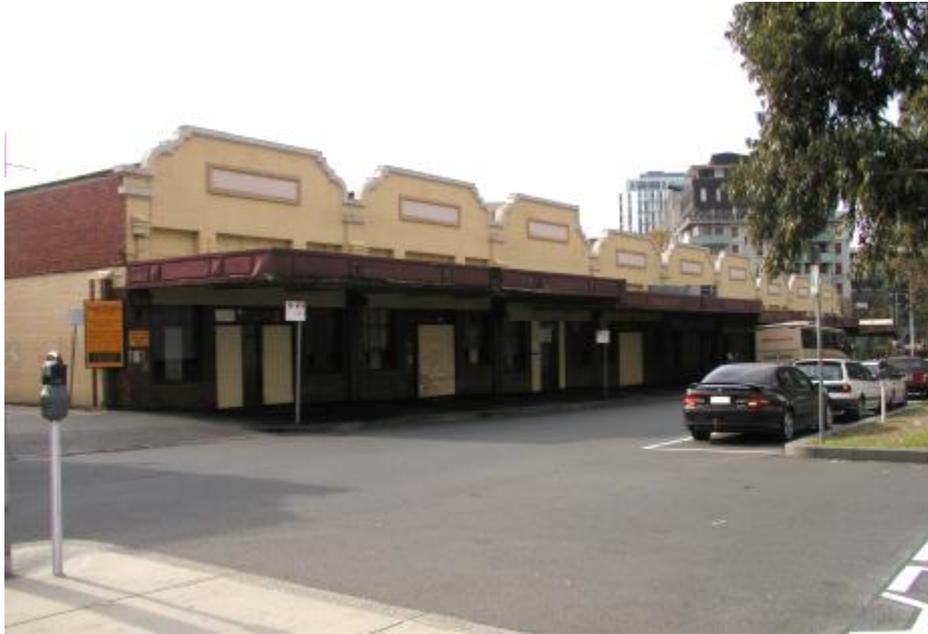
Figure 67 Franklin Street Stores, east row, south elevation

A steel-framed cantilevered verandah awning screens each row, dividing the utilitarian face brickwork below from the rendered parapet above. The awning is clad with steel fascia panels which feature small fielded sections and the Franklin Street awning is detailed to match the awning over the Dairy Hall entrance. At each step in the north elevation the awning is surmounted by a non-original light fitting. Of single-storey form, each double-fronted store is reflected in the vertical division of the elevation into bays by ornate pilasters and the stepped parapet form. The pilasters are designed to contain an integral rainwater head and downpipe and are capped by a simply moulded cornice.

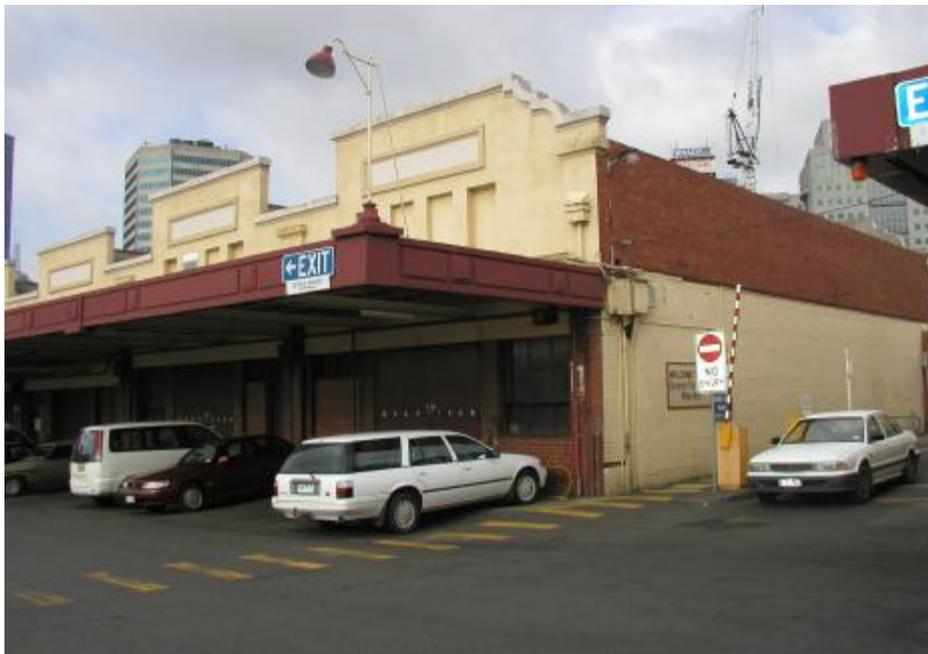
Figure 68 Franklin Street Stores, east row, north elevation

Above the verandah awning on the north elevation each bay contains regular and repetitive fenestration consisting of four window openings which have variously been filled in or altered by the removal of louvred windows and the installation of air conditioning units or steel security grilles. The windows are surmounted by a fielded panel which once contained painted signage of the proprietor of each store. The whole store is surmounted by a simple stepped parapet finished with a squared rendered capping.

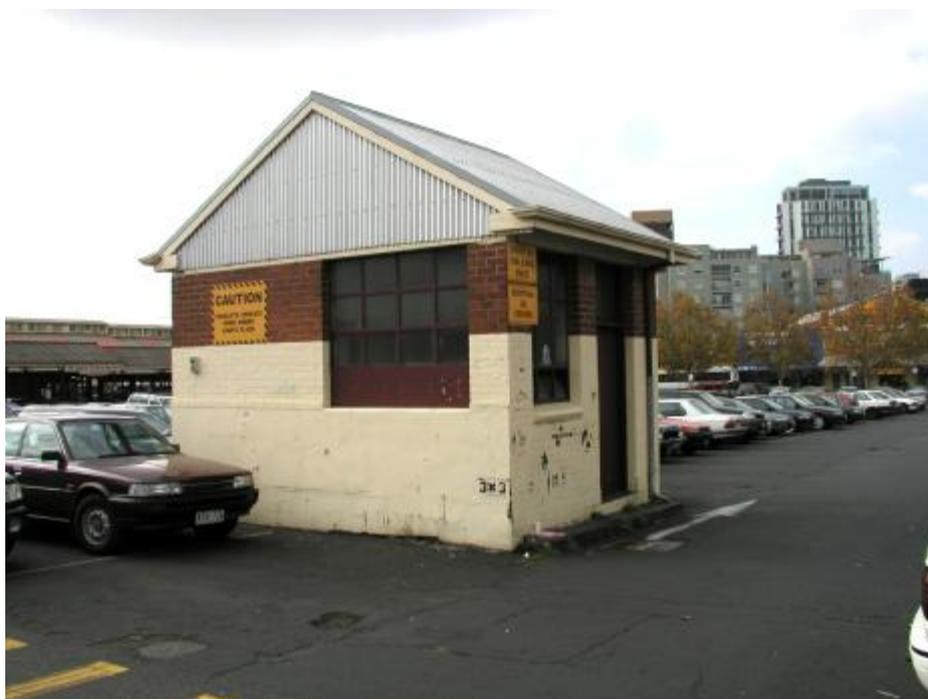
The utilitarian structure is simply finished with concrete floor, bluestone thresholds, rendered walls and tongue and groove timber ceiling linings.

Figure 70 Remnant of former Garbage Transfer Station, carpark site

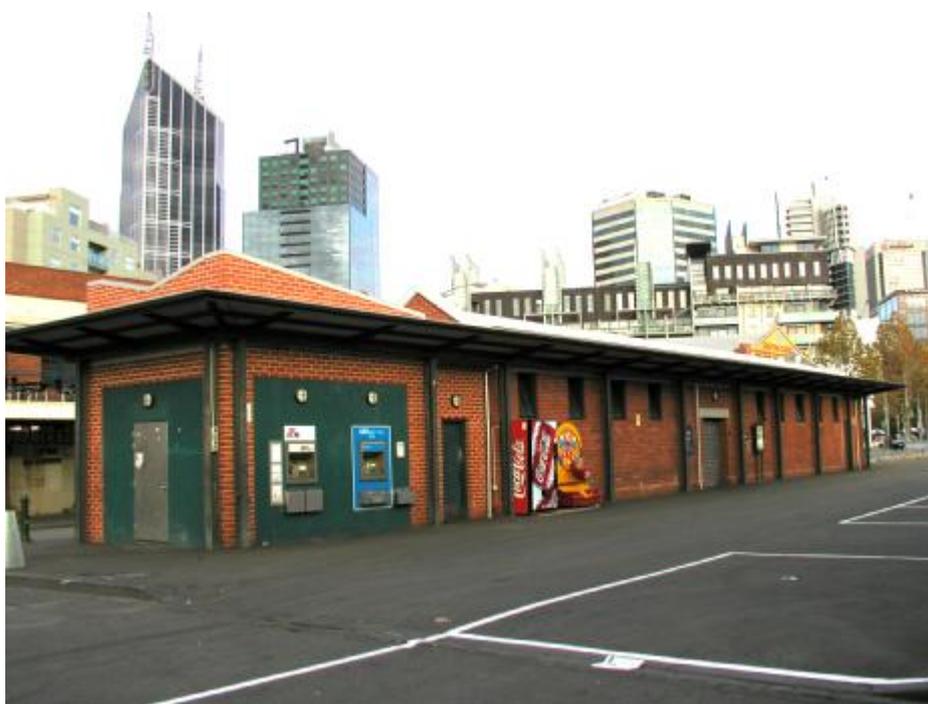
The utilitarian single-storey red face brick building is a long rectangle in plan. The timber-framed gabled roof terminates at either end of the original building with a simple raking parapet and is clad with corrugated galvanised steel. The red brick addition at each end terminates with a butterfly profile parapet wall which screens the pitched roof.

The building is accessed via a large non-original opening on both the east and west elevations which is secured by a steel roller shutter. The openings are flanked on both sides by regularly spaced original timber-framed fixed hopper sash windows, which are replicated in the addition at the southern end. The addition at the northern end of the building contains automatic teller machines mounted within reinforced concrete panels. The entire building is screened by a non-original steel framed cantilevered awning.

Figure 72 Queen Street Amenities Block, west elevation
