La Trobe Street Bicycle Lanes Post Implementation Assessment

11 March 2014

SUPPORTING ATTACHMENT – LA TROBE STREET BICYCLE LANES POST IMPLEMENTATION ASSESSMENT

Post-opening Audit of La Trobe Street Bicycle Lanes – Road Safety Audit Report

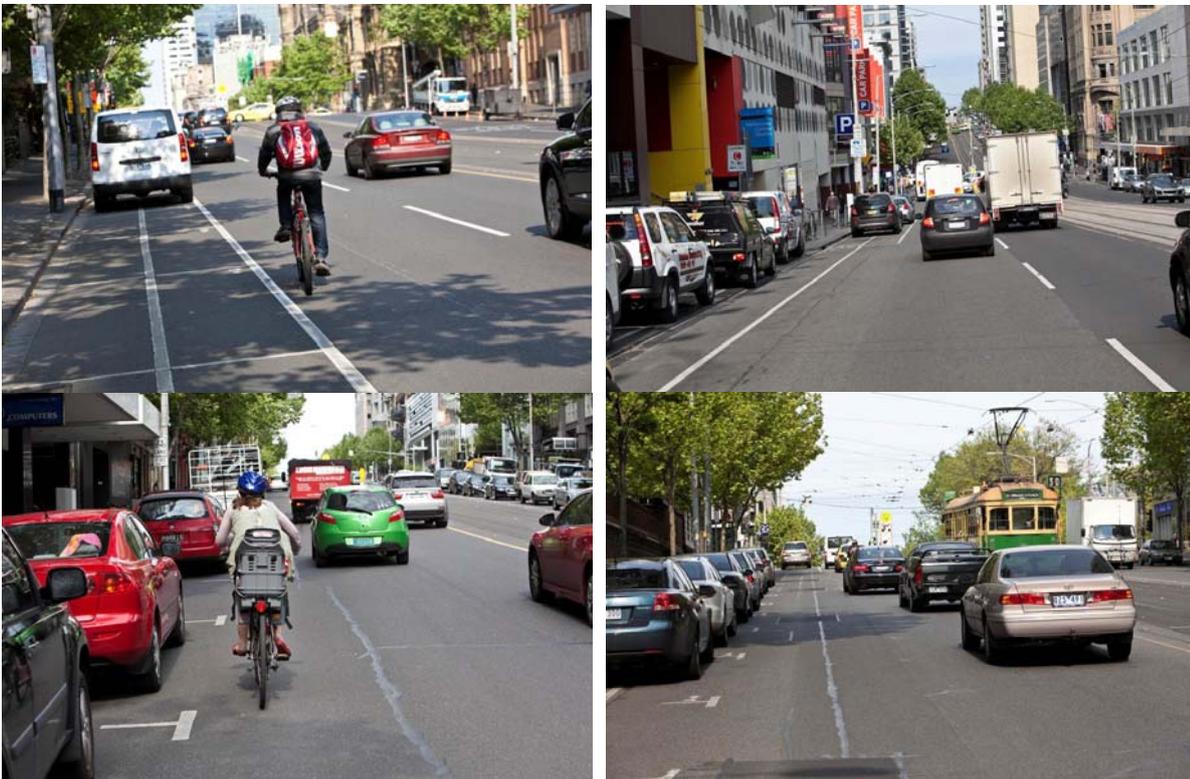
Before photos

Before – La Trobe Street originally operated with one to two traffic lanes, and on-street parking at mid-block locations. Clearways operated along some road sections to improve traffic performance with clearway bicycle lanes.

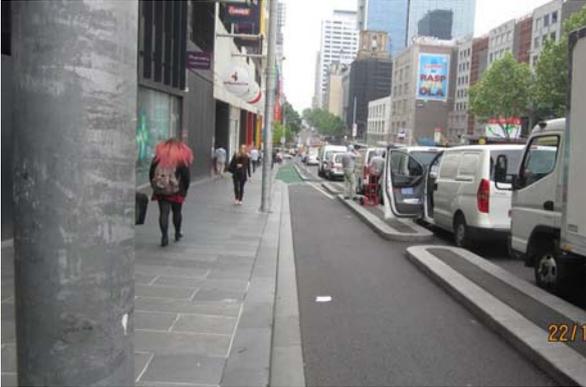
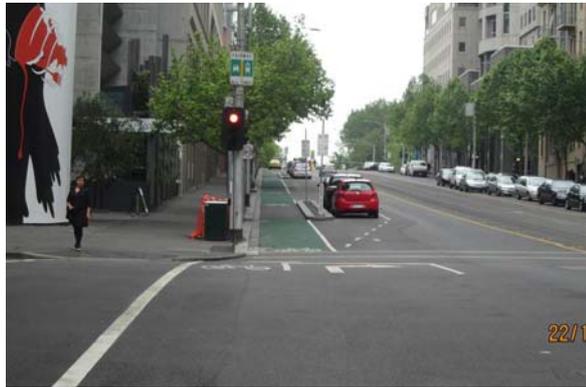
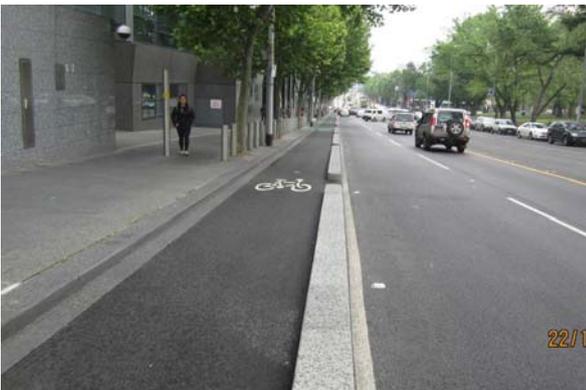
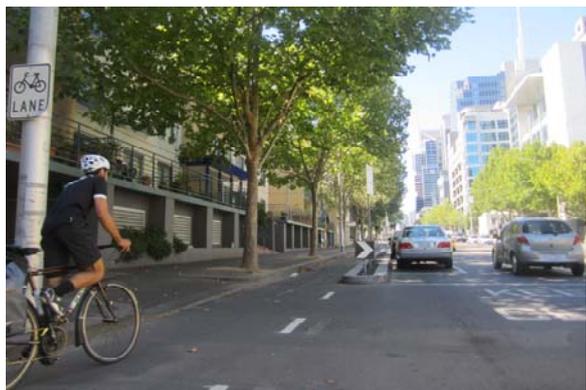
After photos

After – La Trobe Street now provides a physically separated bicycle lane, with a narrow median, on-street parking and one traffic lane. At intersections, the carriageway flares to provide two lanes, to maintain traffic throughput.

Parking has been permanently removed to maintain two through traffic lanes between:

- William Street and King Street westbound
- Swanston to Russell Street – half block eastbound
- Exhibition Street to Victoria Street – eastbound.

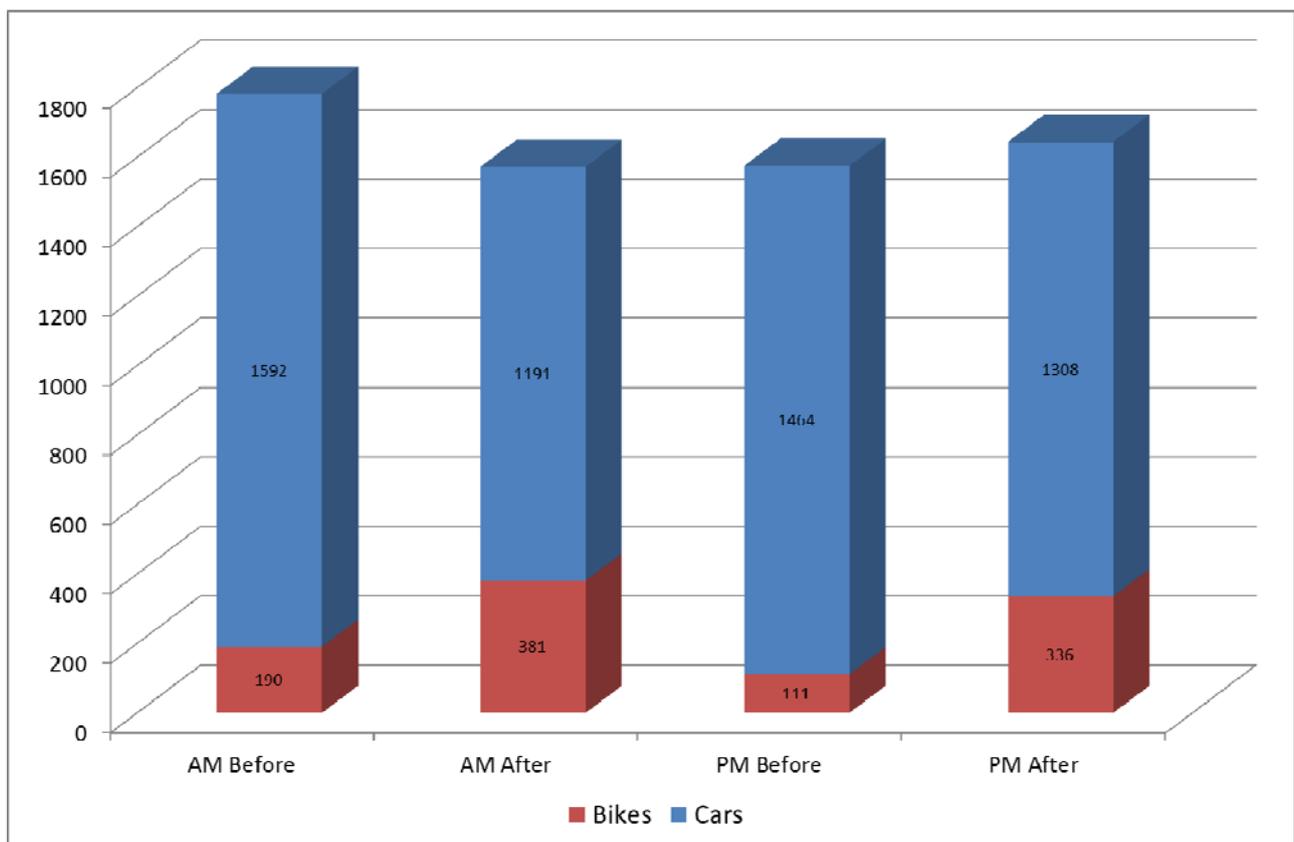
Figure 1 – Before and After Peak Hour Volumes by Mode

A before and after comparison of travel by vehicle mode indicates a significant shift in travel modes.

The following chart highlights the two-way traffic flows in the AM peak (8-9) and the PM peak (5-6pm). (Note: Counts did not include trams).

In 2012, 11% of total cycle/vehicle volumes were by bicycle in the AM peak, but have increased to 24% in 2014. In 2012, 7% of total cycle/vehicle volumes were by bicycle in PM peak, but have increased to 20% in 2014. This represents a substantial mode shift for the route (and is representative of route choice changes, rather than just modal shift).

Whilst overall AM travel movements have decreased (by 210 movements two-way), PM peak travel movements have increased (by 70 movement two-way) generated by the tripling of bicycle movements, despite the reduction of 155 car movements.

Action: *No specific recommendation, monitor travel demands by mode.*

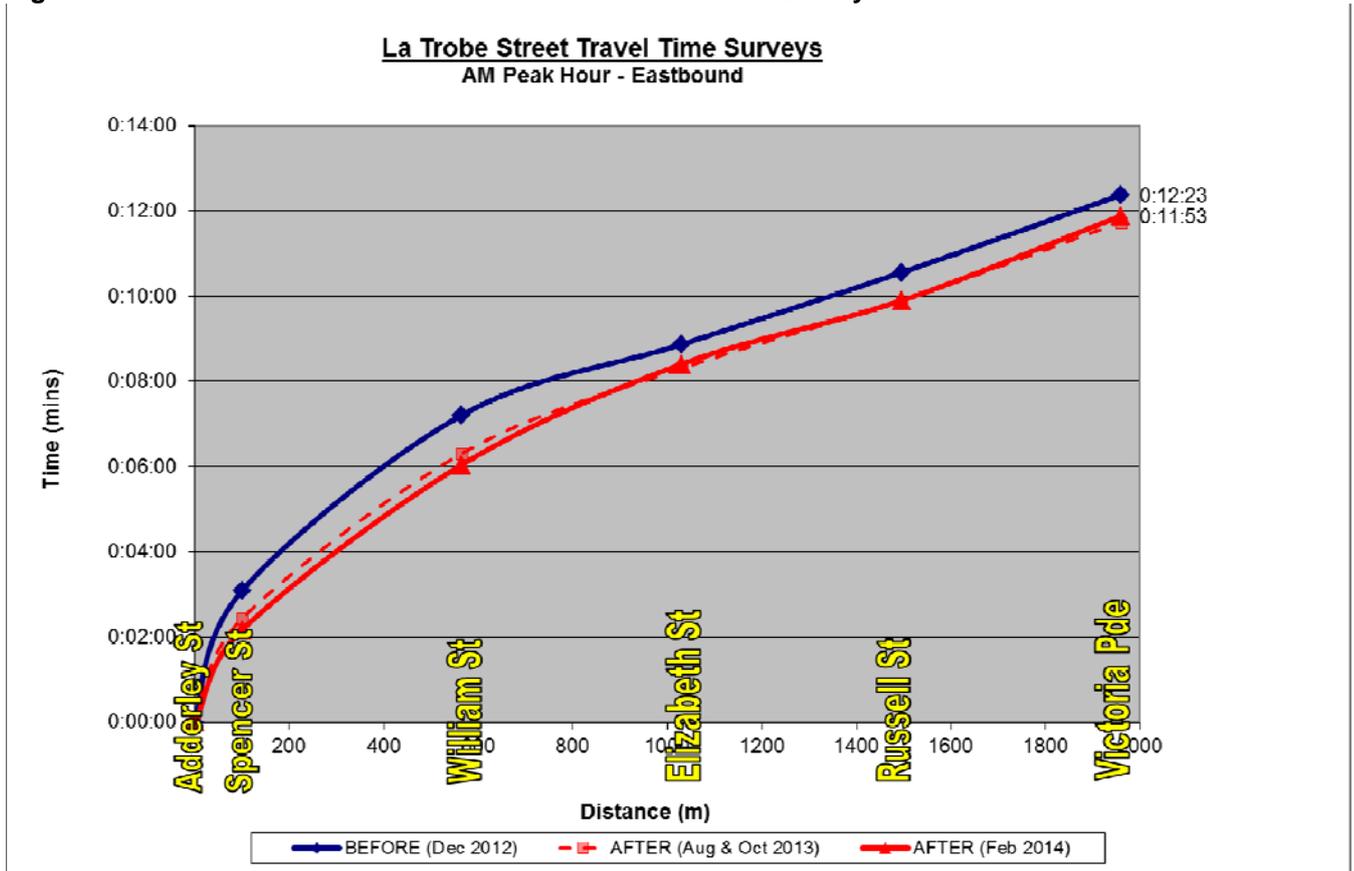
Figure 2 – Eastbound La Trobe Street Vehicles Travel Times Survey – AM Peak

Eastbound travel time survey results are summarised in Figure 2 and 3 for AM peak and PM peak respectively.

Before and after data remains relatively consistent in the AM peak.

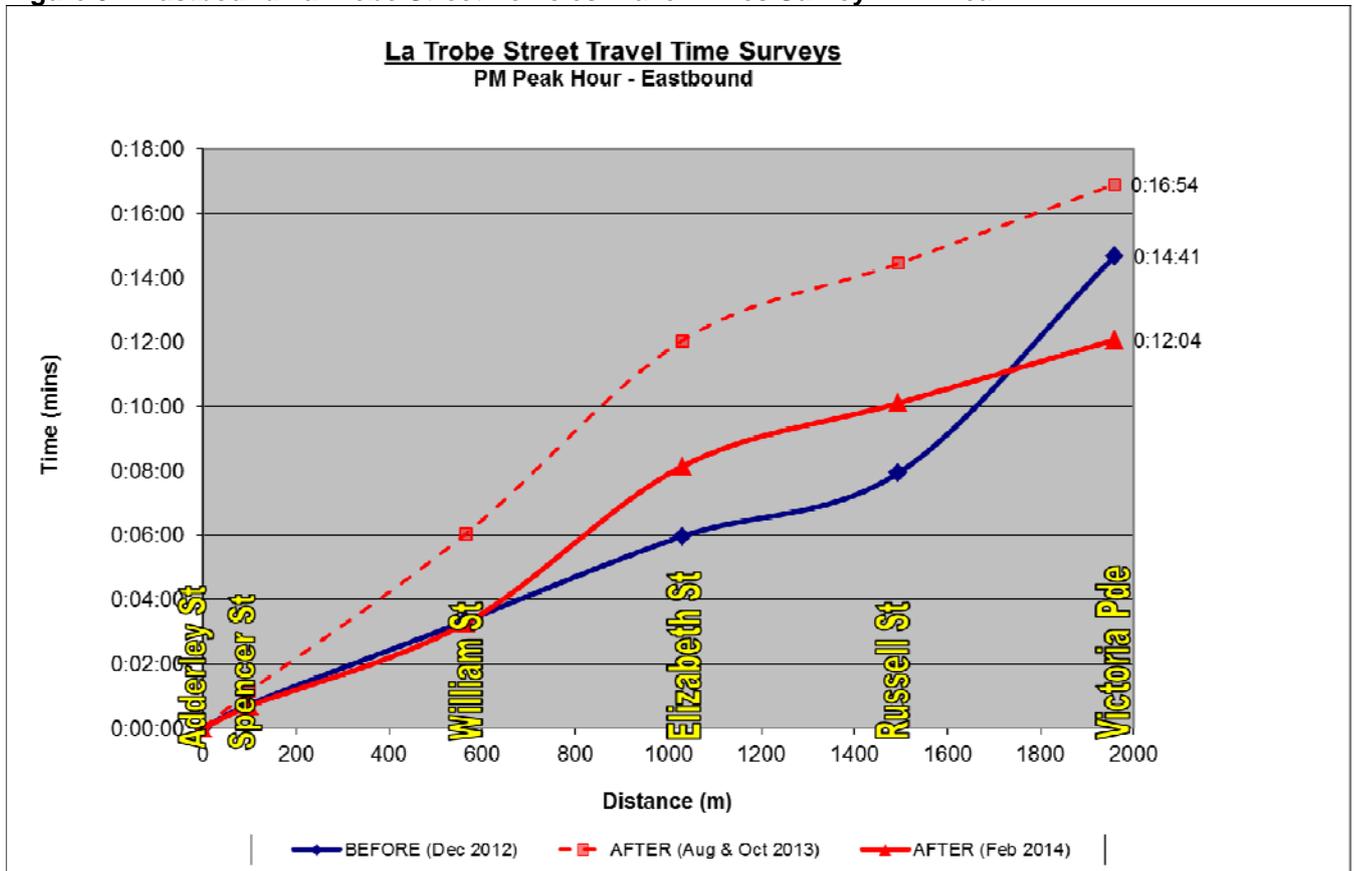
Figure 3 – Eastbound La Trobe Street Vehicles Travel Times Survey – PM Peak

In the PM peak, there were significant delays to reach Elizabeth Street/Swanston Street immediately after the implementation of the bicycle lane. The altered signal timings at Swanston Street have reduced eastbound travel times by around 4 minutes. Delays at the Victoria Parade intersection have also been dramatically decreased since before the bicycle lane, through improvements to signal phasing. As a result, end to end travel times have decreased since before the bicycle lane was introduced.

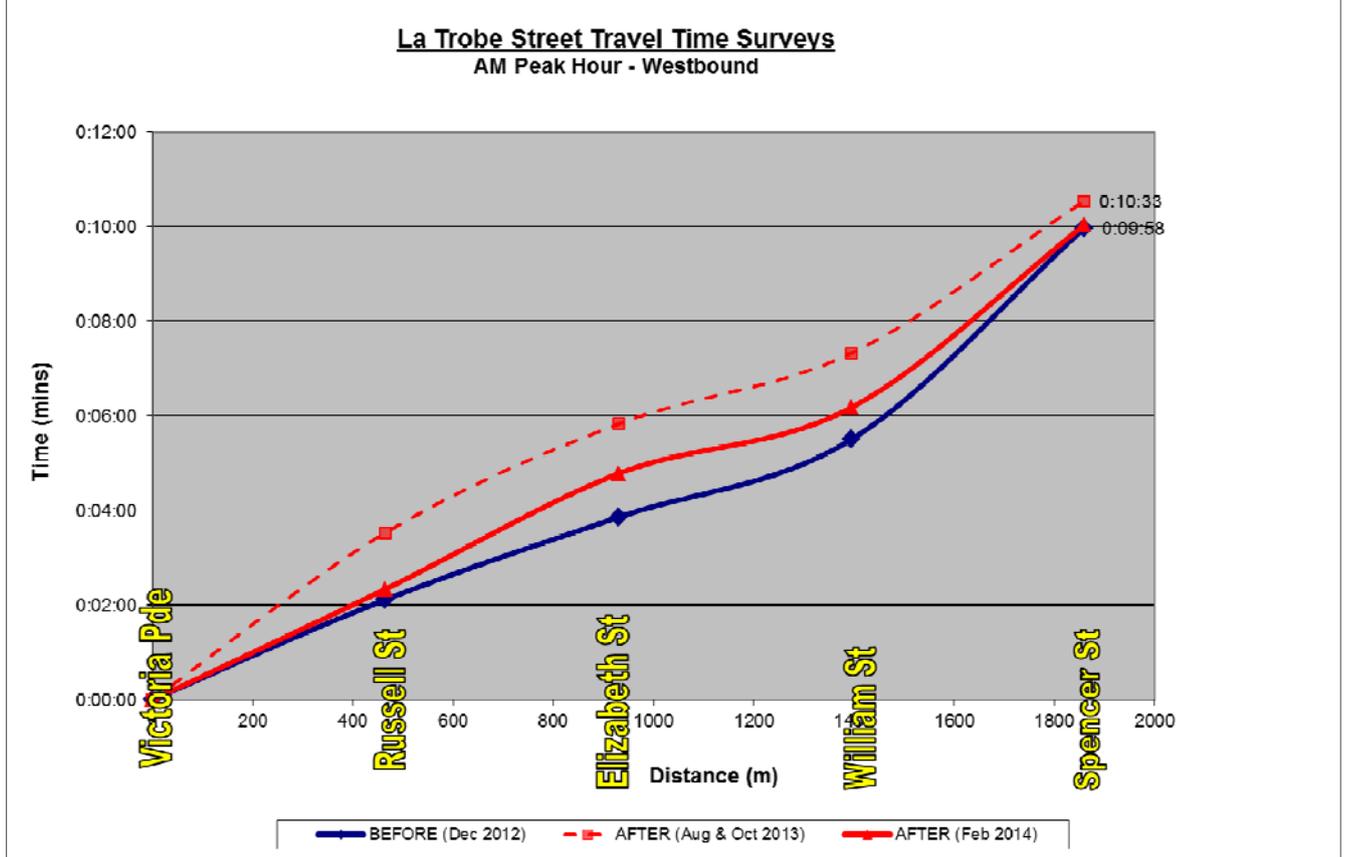
Figure 4 – Westbound La Trobe Street Vehicles Travel Times Survey – AM Peak

Westbound travel time survey results are summarised in Figure 4 and 5 for AM peak and PM peak respectively.

AM peak westbound travel times were initially impacted by 2 minute delays at or around Elizabeth Street/Swanston Street. Post signal changes, the average delay at this section has decreased by 1 minute, and the travel time from end to end is now consistent with pre-implementation travel times.

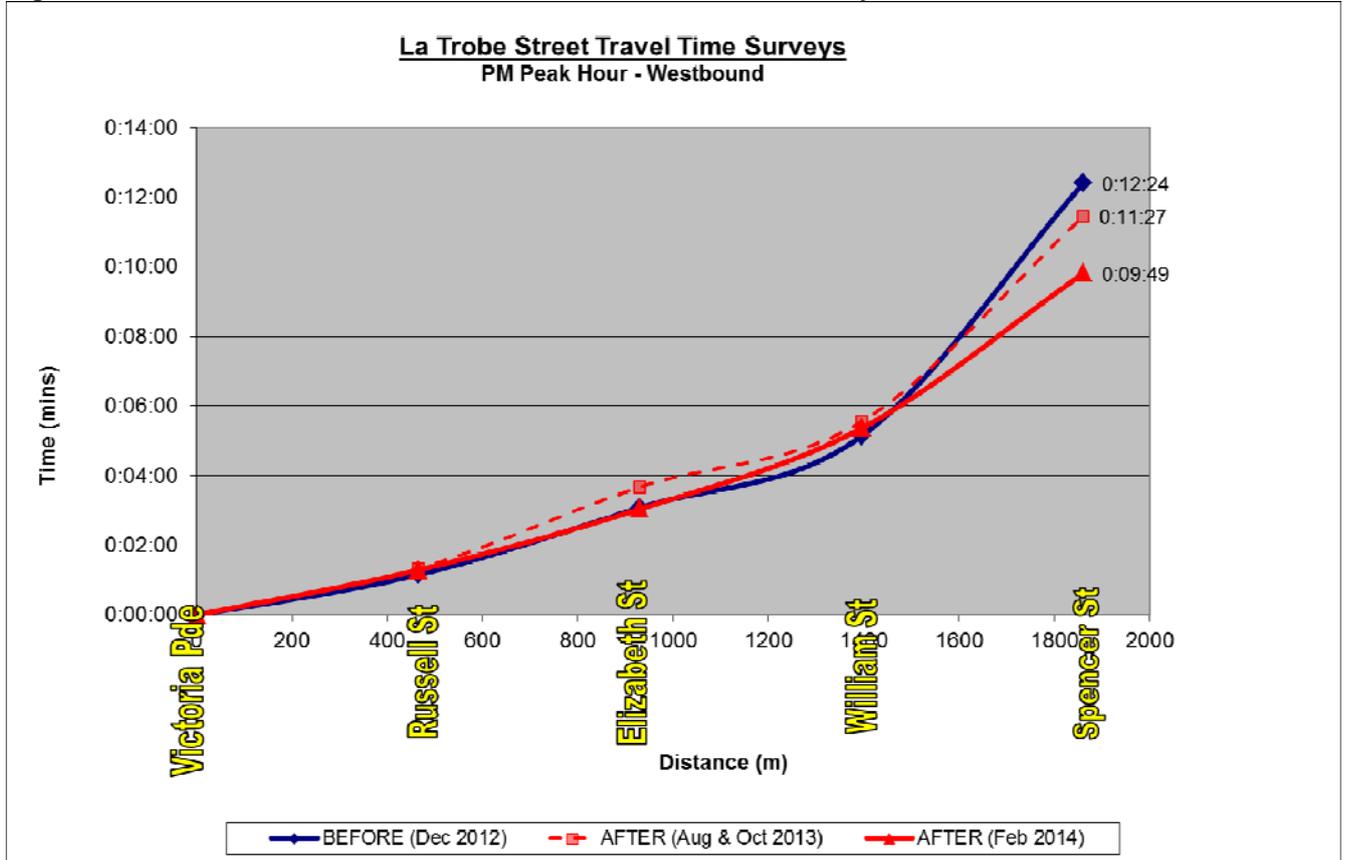
Figure 5 – Westbound La Trobe Street Vehicles Travel Times Survey – PM Peak

PM peak before and after data remain relatively consistent, with some fluctuations to delays near Spencer Street, which are likely to be unrelated to the bicycle lane.

Action: *No specific recommendation, continue to monitor travel times.*
