**In the matter of 85-89 SUTTON STREET, NORTH MELBOURNE
AMENDMENT C207 TO THE MELBOURNE PLANNING SCHEME: ARDEN
-MACAULAY HERITAGE AMENDMENT**

Expert Witness Statement of Mr Kevin Desmond Campbell

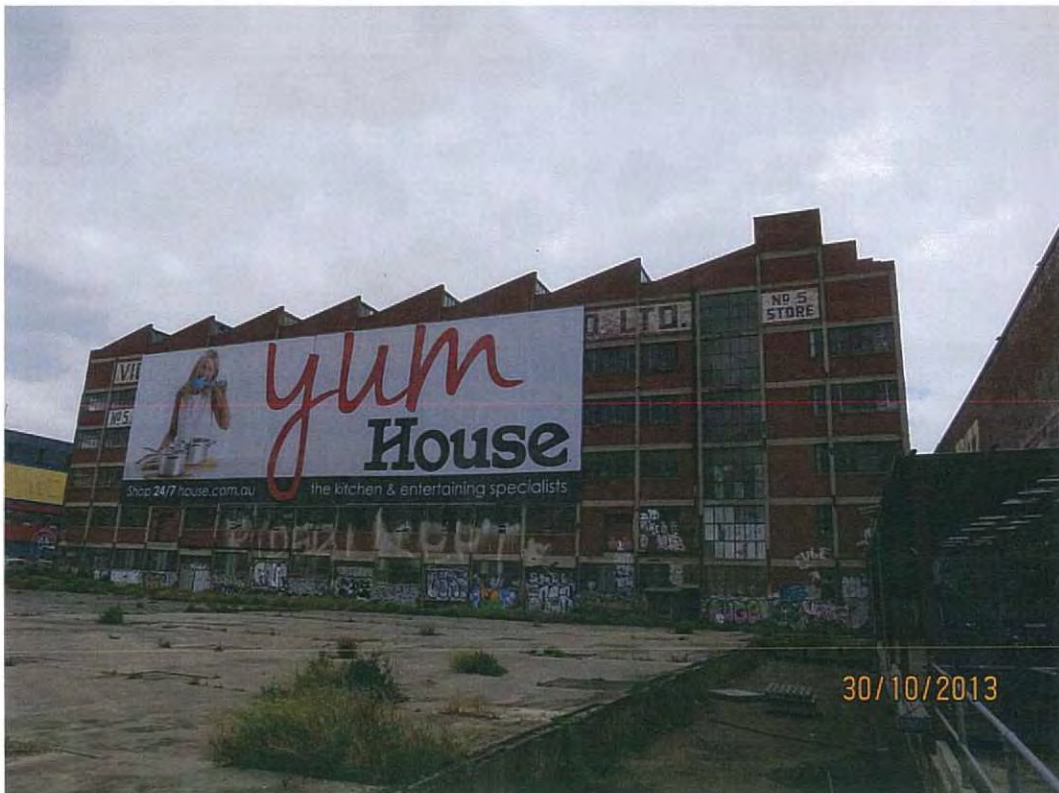
Southern elevation spray painted to match brick work and conceal distress.
Part eastern elevation – note: no expansion joints in southern elevation or eastern elevation. No capping on saw tooth brickwork. Capping on plant room brickwork
